STEEL CONSTRUCTION

TODAY & TOMORROW

Special Feature: The 2011 Great East Japan Earthquake

- 1 How to Interact with and Prepare for Natural Disasters?
- 3 Coastal Facilities: Lessons Learned from the Quake and Tsunamis
- 6 Damage to River Levees and Measures for Restoration and Reconstruction
- 9 Liquefaction-induced Damage to Houses and Buried Lifelines
- 15 Treatment of Debris and Tsunami Deposits, and Their Effective Utilization for Restoration and Reconstruction

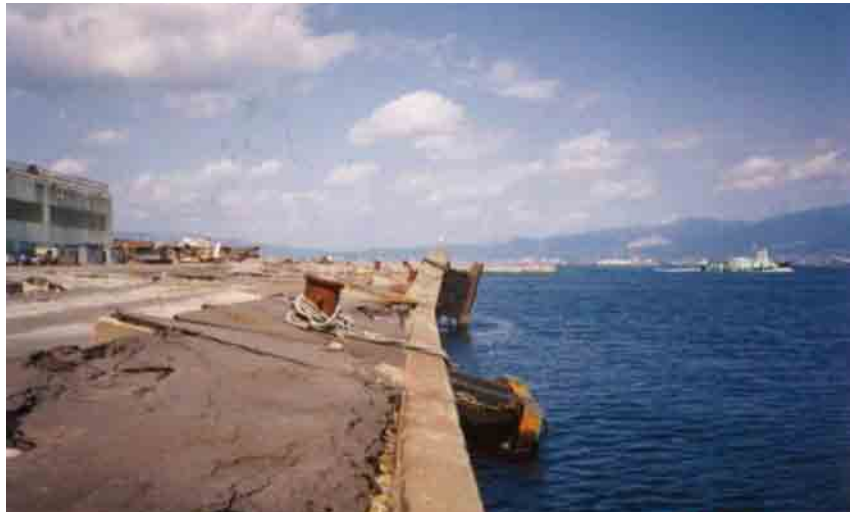
Photo 1 Damage to the steel sheet pile quay wall of Hakodate Port during the 1993 Hokkaido-Nansei-Oki Earthquake

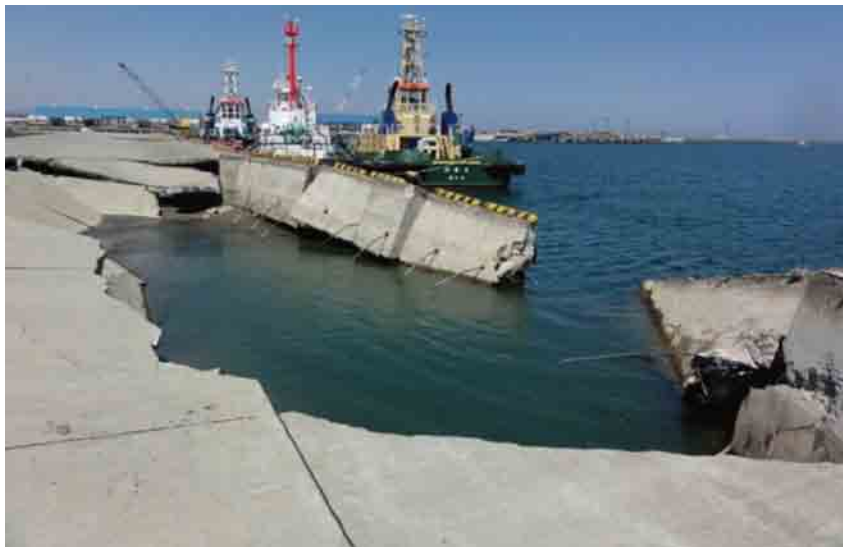
Now, consideration is made on the damage to the steel sheet pile quay wall in Soma Port during the 2011 off the Pacific coast of Tohoku Earthquake, shown in Photo 2. It is reasonable that the damage of quay wall occurred as a result of the action of ground motion and subsequent tsunami. However, in the post-disaster field investi-

gations, there are many traces of the damage caused by the ground motion that cannot be separated by the action of the tsunami. Accordingly, from the difference between damage caused by ground motion and caused by tsunami, the cause of damage will be pursued. The difference between Photos 1 and 2 is that, while almost the same degree of damage occurred in both quay walls, the entire damage occurred in the quay wall in Photo 1. On the other hand, in Soma port, damage occurred only to the corner and about 30 m part of entire quay wall, but other parts are quite healthy (Photo 3). The detail of the failure process at that moment is not known. I plan to carry out efforts to clear the failure process by experiments and numerical analyses.

Photo 2 Damage to the steel sheet pile quay wall of Soma Port during the 2011 Off the Pacific coast of Tohoku Earthquake

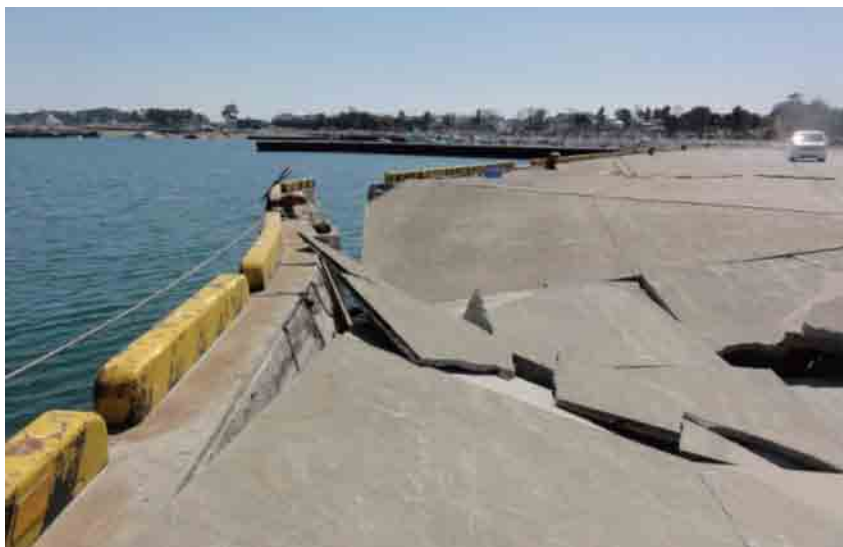
Photo 3 Damage to the steel sheet pile quay wall edge portion in Soma Port during the 2011 Off the Pacific coast of Tohoku Earthquake

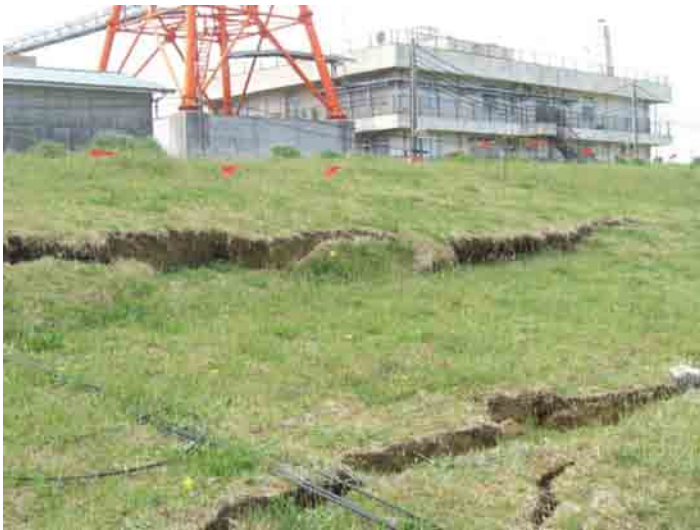
Figure 1 shows the location of rivers and levees to be discussed in this article. First, the levee of the Tone River at Sawara (Photo 1) demonstrates a typical damage of levee or embankment resting on liquefied subsoil; subsidence at the top and longitudinal cracks caused by lateral spreading. As is often the case, this site used to be a part of a river channel, and was filled with sandy soil artificially or naturally, forming a liquefaction-prone subsoil condition.

Photo 1 Significant distortion of levee of Tone River in Sawara

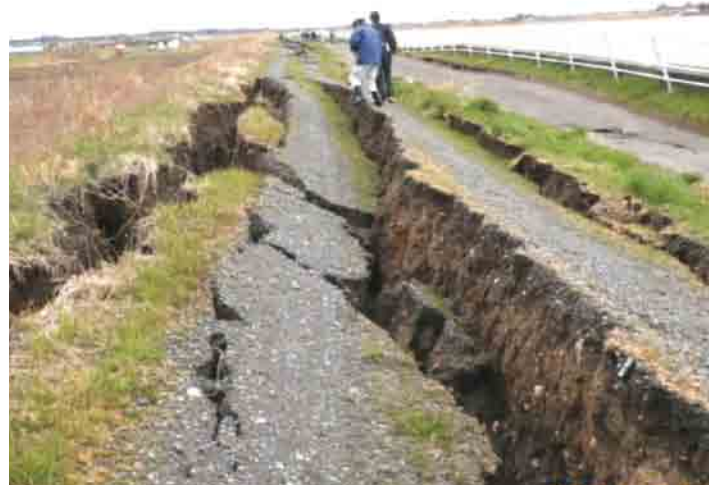
A noteworthy case was such as in Photo 2 in which a heavy distortion occurred in spite of the clayey and hence unliquefiable subsoil. Because the induced deformation of such

levees consists of subsidence at the crest and lateral spreading, which is a typical nature of liquefaction-induced deformation of an embankment, those damage shown in Photo 2 is inferred to have been caused by liquefaction inside levee bodies. The mechanism of this new idea is considered to be as what follows as studied by Sasaki et al. (1994)¹⁾ and Kaneko et al. (1996)²⁾ on previous cases of Tokachi and Kushiro Rivers in 1993 (Fig. 2):

Photo 2 Significant distortion of the Hinuma levee

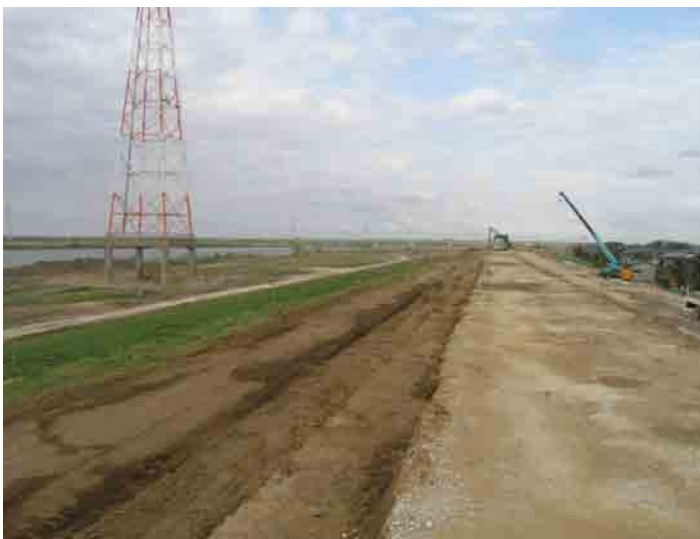
At Sakae of Ibaraki, the Tone River levee had been reinforced by underground sheet pile walls (for reducing seepage of water) accompanied by a wide berm on the river side. During the earthquake, no distortion occurred on the river side (Photo 3). In contrast, the land side of the levee distorted due to liquefaction in the foundation soil in which the ground water level is within 50 cm from the surface (the author's observation in April, 2012). The damaged section was restored by installing 8-m sheet piles along the slope toe (Photo 4). The holes in the sheet pile allow seepage of ground water so that the water level in the levee would be lowered during high water level in the river.

Photo 3 River side of Tone River levee at Sakae without damage (entire restoration of the levee going on in April, 2012)

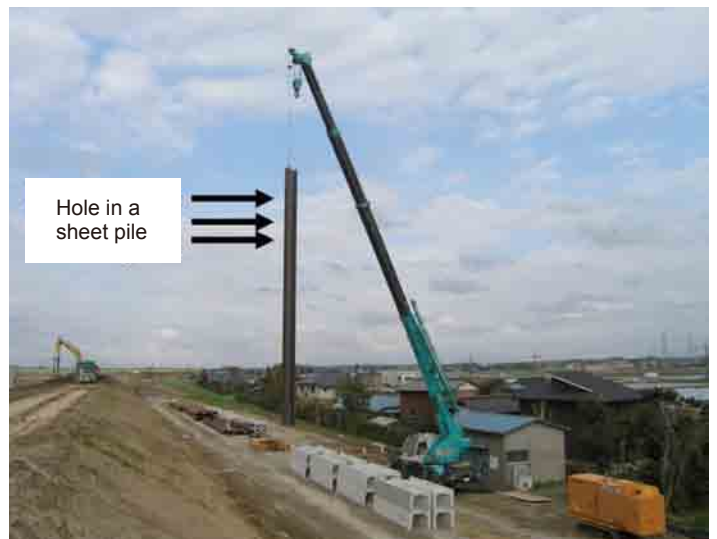
Photo 4 Reconstruction of land side of Tone River levee at Sakae by installing sheet pile walls with holes

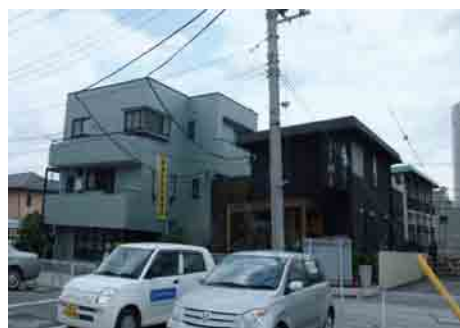
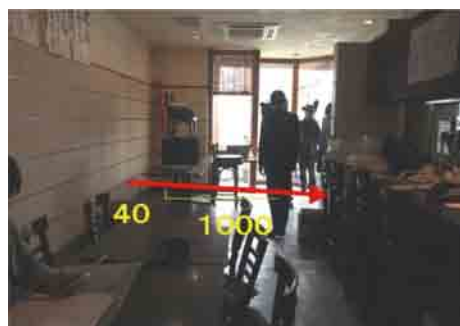
According to the result of totaling by the Ministry of Land, Infrastructure, Transport and Tourism, about 27,000 houses were damaged due to liquefaction (Table 1). Photos 2 (1~2) show a damaged house taken from outside and inside respectively. The house settled and tilted about 40/1,000. In the heavily tilted houses, inhabitants feel giddy and nausea and difficult to live in their houses after the earthquake. However damaged houses due to liquefaction had been judged as partial collapse or injured only during past earthquakes because of no damage to walls and windows, though it has been desired both settlement and inclination must be considered in the judge.

(1) Outside of the tilted house

(2) Inside of the tilted house

Photo 2 Severely settled and tilted house in Urayasu City

Many inhabitants along Tokyo Bay are facing to the serious problem, how to restore the damaged houses. Complicated problem is the re-liquefaction during aftershocks or future earthquakes. Not only the restoration but also some countermeasure against re-liquefaction must be applied, but the problem is the cost and the technique to treat the ground under existing structures. Then early development on effective and economic measures against

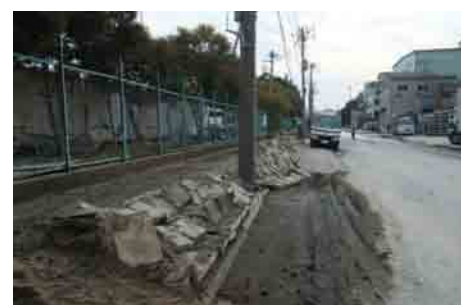
Miracle phenomena, heaving, buckling or thrust, were observed at several footways and alleys as shown in Photo 3 at many sites in Tokyo Bay area. Some thrust might occur at the

Photo 3 Heaving of a footway at Takahama, Ichikawa City

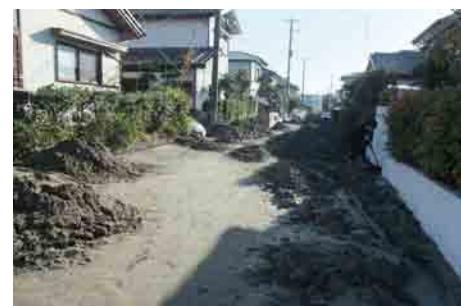
Photo 4 Thick boiled soil observed in Chiba City

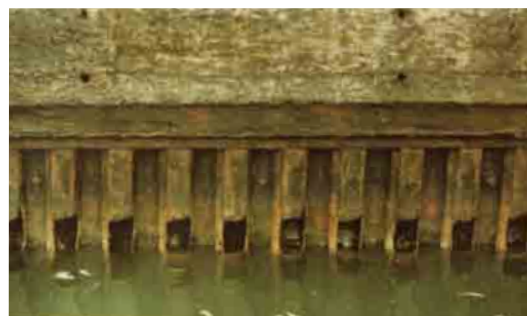
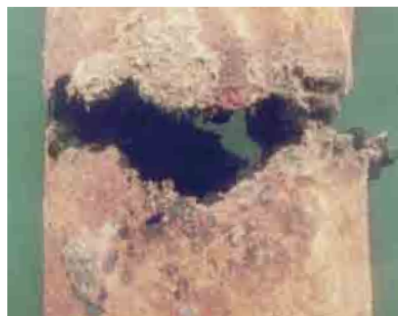
Photo 1 Local corrosion that occurred in port structures: steel sheet pile (left) and steel pipe pile (right)
