Durability Assessment of Various Kinds of Construction Materials by Means of Long-term Exposure Tests

—Durability Assessment by Means of Exposure Tests at Okinotorishima and Suruga Bay—

Research Group on Corrosion Protection and Durability of Offshore Steel Structures Committee on Overseas Market Promotion

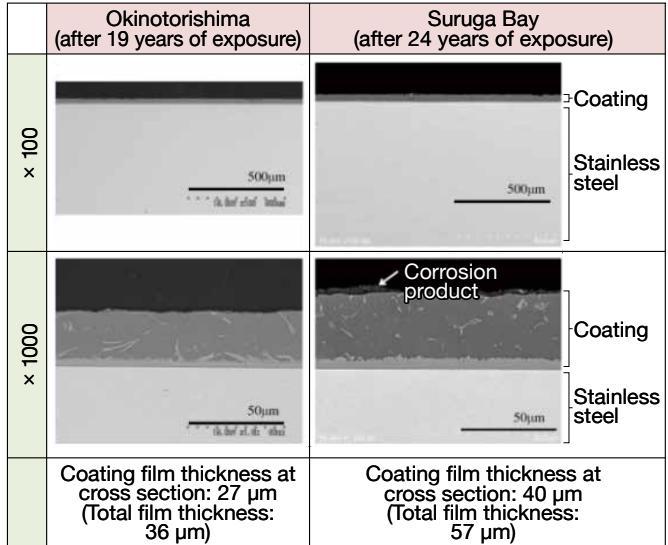
Fig. 4 SEM Images at Cross Sections of Aluminized Stainless Steel Plates

As shown in Fig. 4, as for the aluminized stainless steel plate (D-01), while the formation of corrosion products was observed at both testing sites, the aluminum coating layer remained, and thus it is assumed that the aluminized stainless steel plate had sound corrosion-protection performance. As for the hot-dip galvanized plate (D-02), as shown in Fig. 5, the galvanized layer nearly completely disappeared after 19.5 years of exposure at Okinotorishima, but the galva-

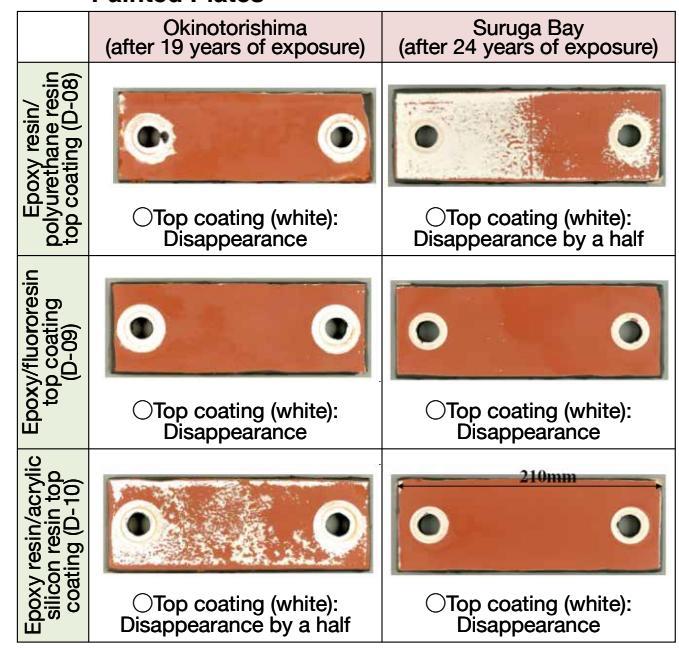
Fig. 9 Surface Appearances of Heavy-duty Painted Plates

primer coating, the annual average film thickness loss rate of lined/coated/painted plates is shown in Fig. 8. Fig. 9 shows the surface appearance of heavy-duty painted plate. In the figure, the surface where top coating was completely lost can be seen for respective heavy-duty-painted plates at both testing sites.

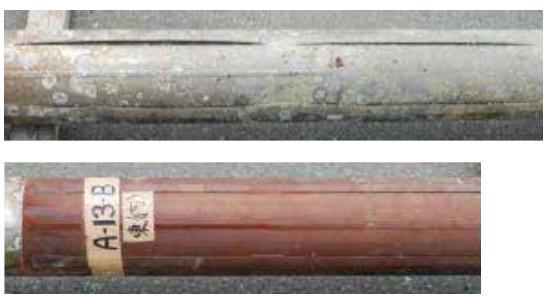
Photo 3 Titanium-lined Specimen after 30 Years of Exposure (Top: Submerged Zone; Botttom: Splash Zone)

As for the titanium-lined specimen, a titanium piece was partially weld-joined to a specimen in order to artificially cause crevice corrosion. Photo 3 shows the condition of the titanium-lined specimen after 30 years of exposure. Corrosion was not observed beneath the organism-adhered section, and crevice corrosion was also not observed even at

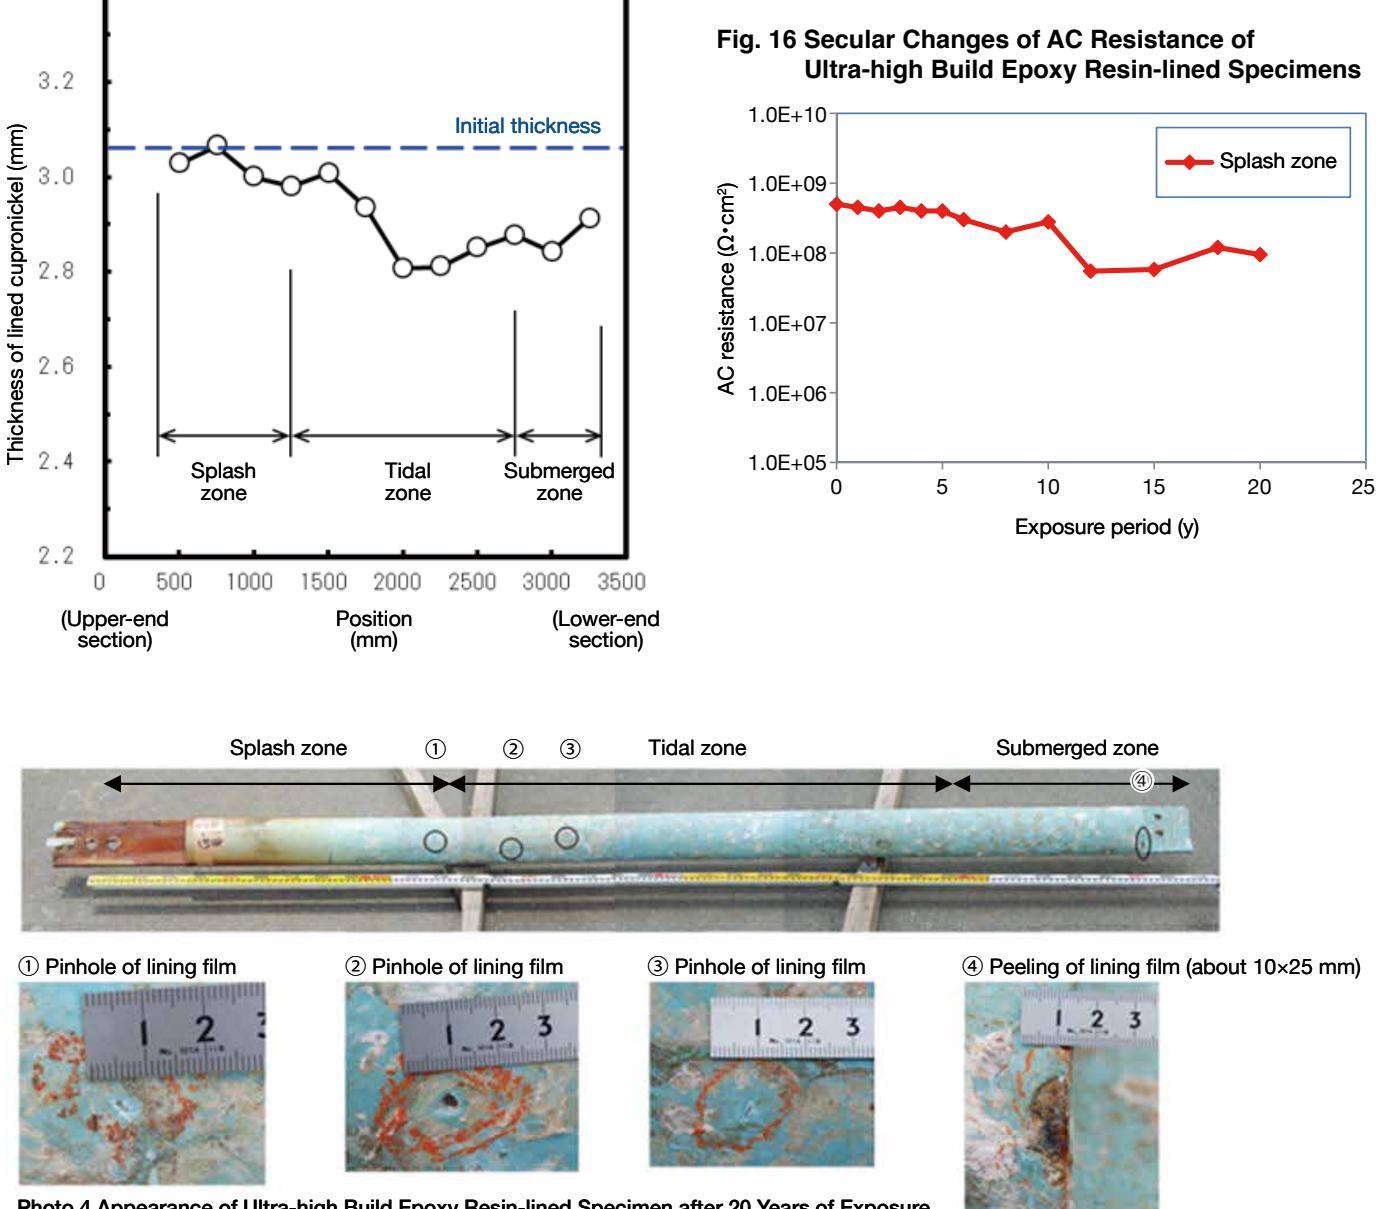
Photo 4 Appearance of Ultra-high Build Epoxy Resin-lined Specimen after 20 Years of Exposure

Photo 4 shows the appearance of the ultra-high build epoxy resin-lined specimen after 20 years of exposure. While corrosion of the exposed steel product was partly found in the section like bruising, deterioration such as film thickness loss and cracking was not observed, and thus the specimen maintained a sound condition. Fig. 16 shows the secular change of AC resistance in the splash zone. A high resistance of $10^8 \,\Omega \cdot cm^2$ was maintained over the long term. It was also confirmed from the section-wise measurement results for the specimen raised from the testing site that no difference in deteriorated conditions between tidal and submerged zones was observed. Also, no considerable loss of film thickness due to the lapse of exposure years was observed. To these ends, it was found that corrosion-protection performance was maintained for ultra-high build epoxy resin-lined specimens.

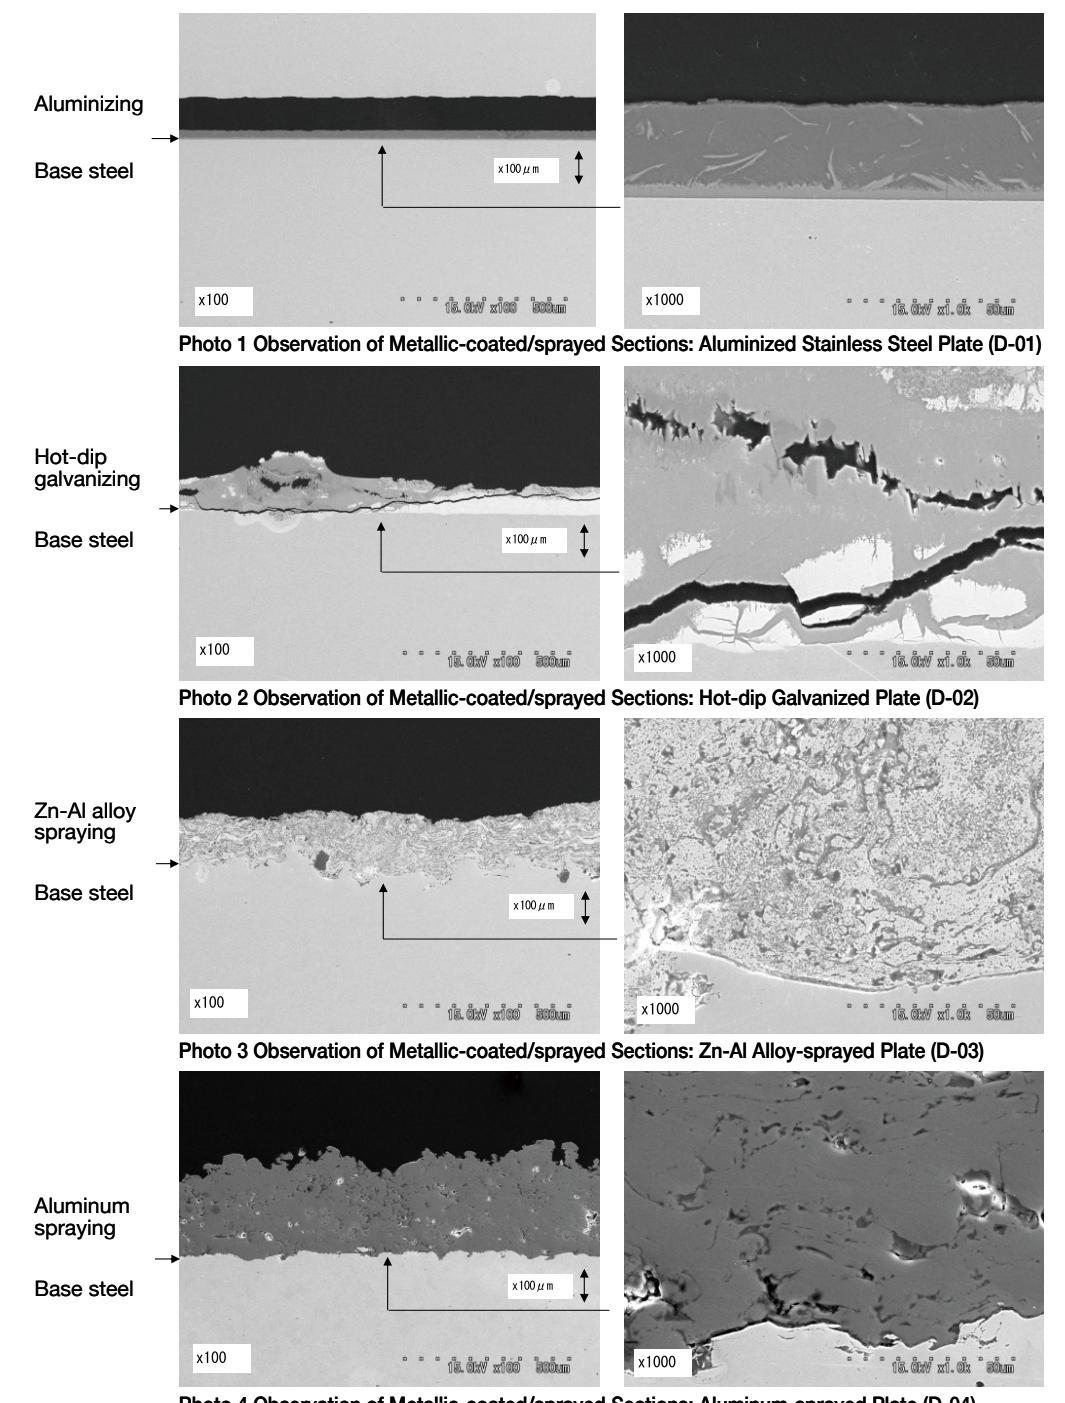
Photo 4 Observation of Metallic-coated/sprayed Sections: Aluminum-sprayed Plate (D-04) Measurement instrument: Scanning electron microscope (SEM) S4300SE by Hitachi Ltd.

As for the aluminized stainless steel plate (D-01), the aluminizing layer soundly remained. Accordingly, it was considered that D-01 still possessed corrosion-protective performance. As for the hot-dip galvanized plate (D-02), the galvanizing layer disappeared, and cracks occurred in the zinc-iron alloy layer, from which rust developed. As for the zinc-aluminum alloy-sprayed plate (D-03) and aluminum-sprayed plate (D-04), a spraying layer of 100 μ m or more still remained, and thus it was considered that these plates possessed corrosion-protective performance. In the spraying layer, it was observed that the gap probably formed during spraying developed.

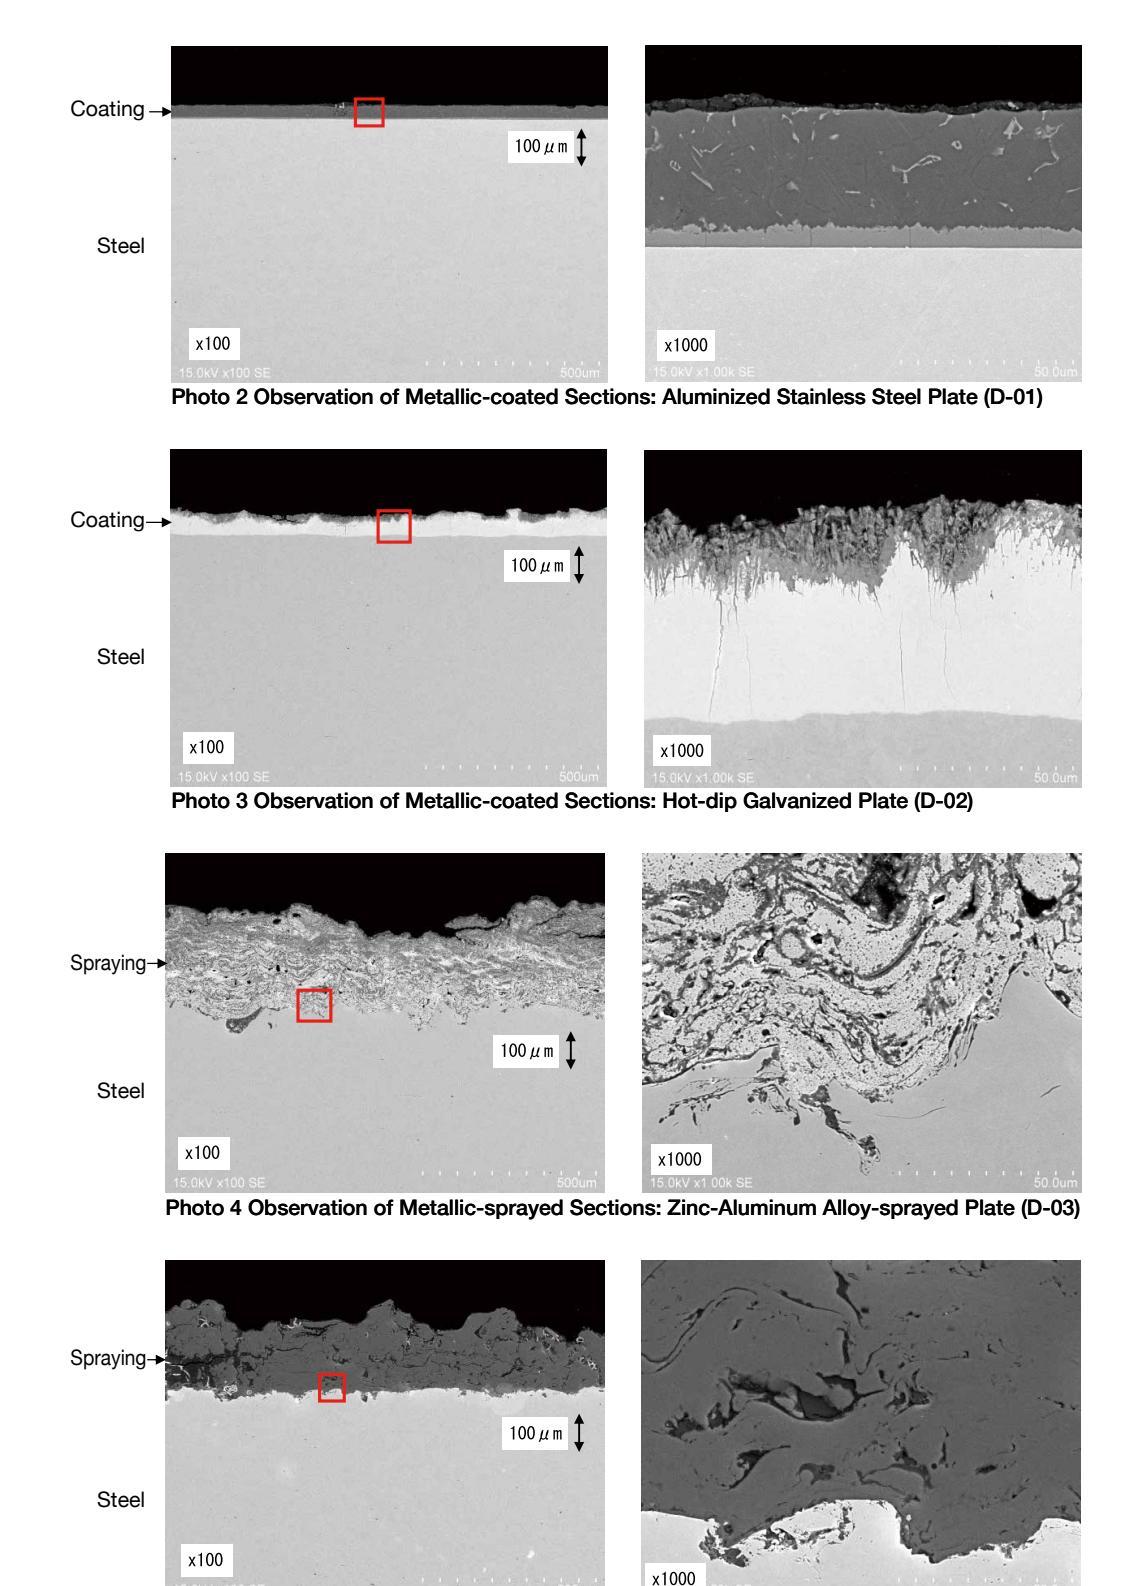
Photo 5 Observation of Metallic-sprayed Sections: Aluminum-sprayed Plate (D-04)

As for the zinc-aluminum alloy-sprayed plate (D-03) and aluminum-sprayed plate (D-04), the sprayed layer of 100 μ m or more remained, and thus it is considered that these plates maintained corrosion resistance.
