No. 35

March
2012

STEEL CONSTRUCTION TODAY & TOMORROW

A Joint Publication of The Japan Iron and Steel Federation and Japanese Society of Steel Construction

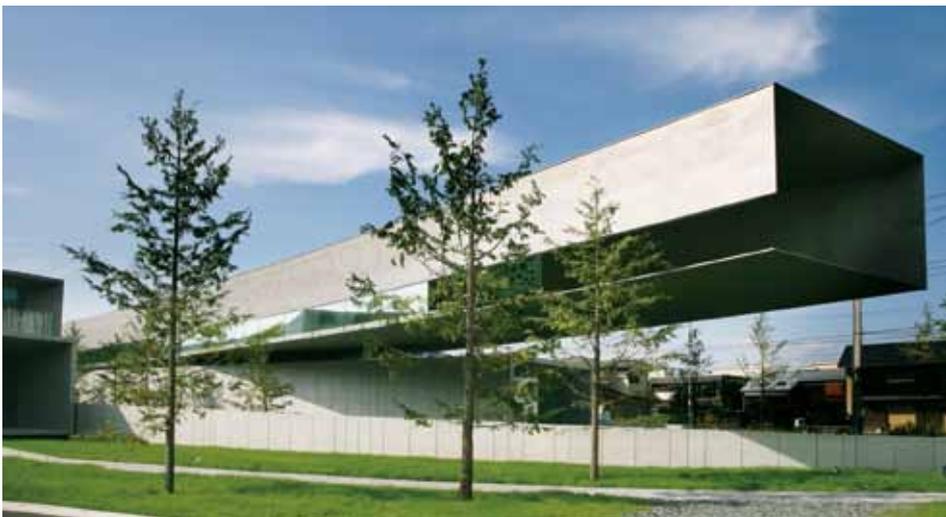
Photo 1 Full view of box-shaped steel-plate structure

A notable structural feature of the Hoki Museum is the 100 m-long box-shaped steel plate structure that constitutes one section of the museum. Supported at two points so that it floats above the lower structure, the box-shaped section is cantilevered for 30 m at one end (Photo 1). This structural system expresses the architectural concept of “floating in the forest.”

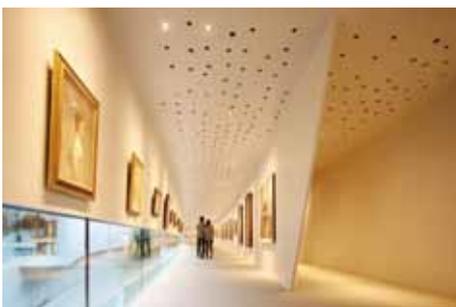
Photo 4 Inner view of box-shaped steel-plate structure

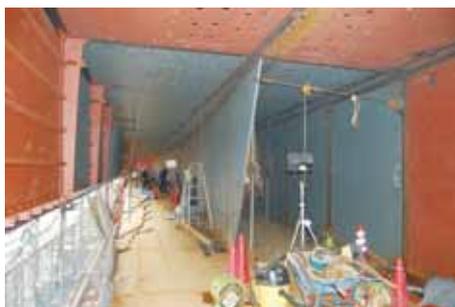
Photo 5 Construction of box-shaped steel-plate structure

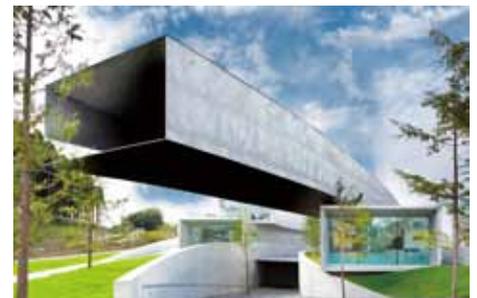
Photo 2 Cantilever structure

Jutting outward in one direction, the box-shaped girder has a cross-sectional configuration consisting of two walls, and two floors (a floor and a roof). The outer wall of the box beam has a gentle arc shape (Photos 2 and 3), the undulation of which is overlapped by the inner wall that serves as an exhibition wall. Since the overlapped section houses the stairs, adequate overlap was provided in the front and rear of the stairs. Therefore, resis-

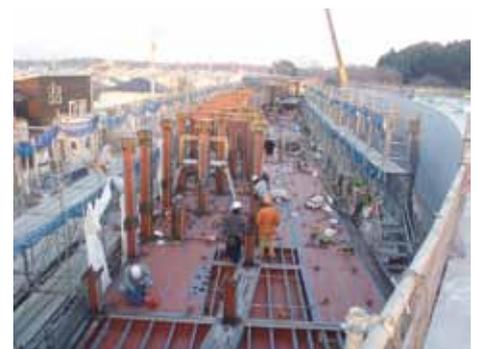
Photo 3 On-site construction

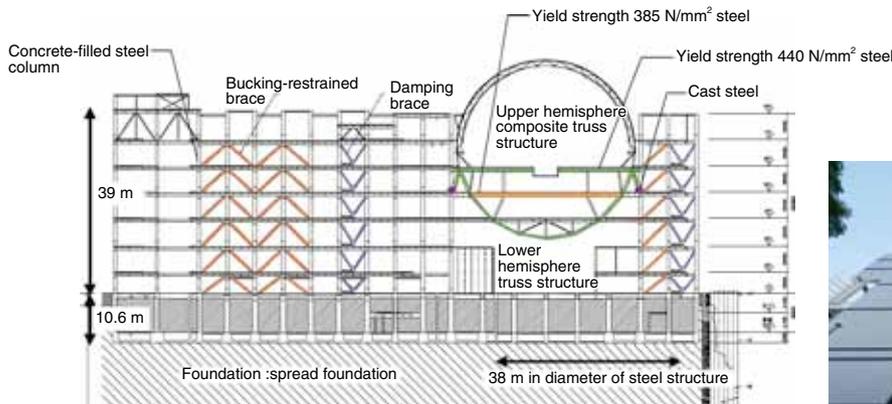
Fig. 1 Section of Nagoya City Science Museum

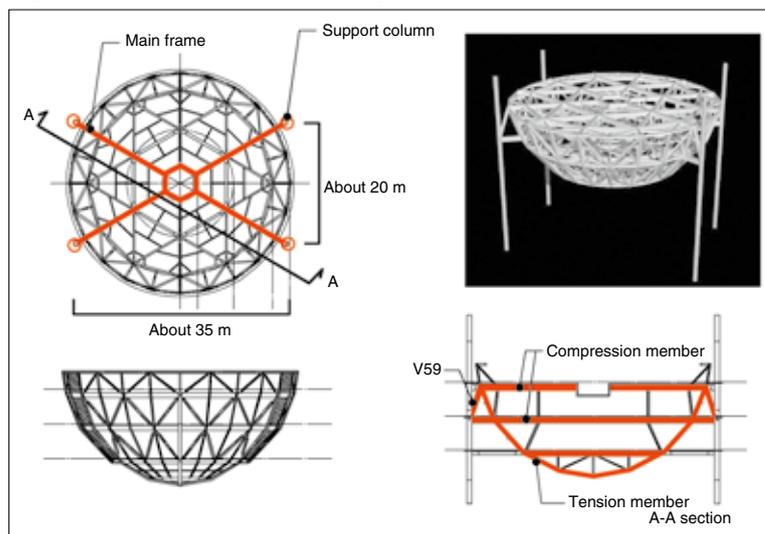
Fig. 2 Structure of Lower Hemisphere

In constructing the lower hemisphere,

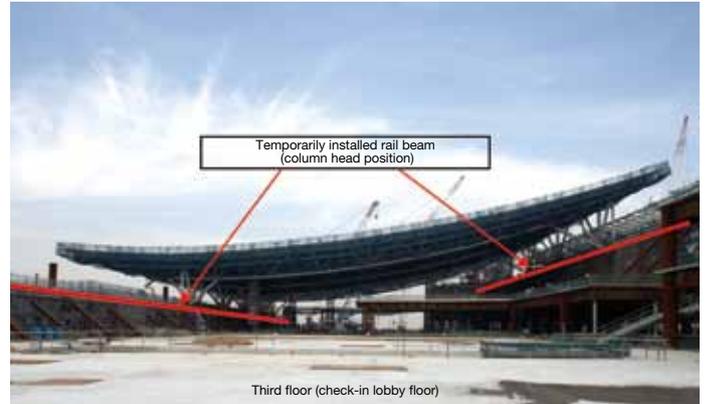
Photo 2 Fifth sliding
Sliding from the rear (north side) to the front (south side) in 6~8 hours

involved 9 rows of connected space truss frames weighing about 5,000 tons, the roof was slid using two PC wire strands (28.6 dia.) set on each column head and two 50-ton center hole jacks. The jacks moved the heavy roof by use of the stroke of the jacks with the reaction set ahead of 2 spans (L=36 m). The stroke position and loading condition of each jack were automatically controlled employing a built-in CPU control box.

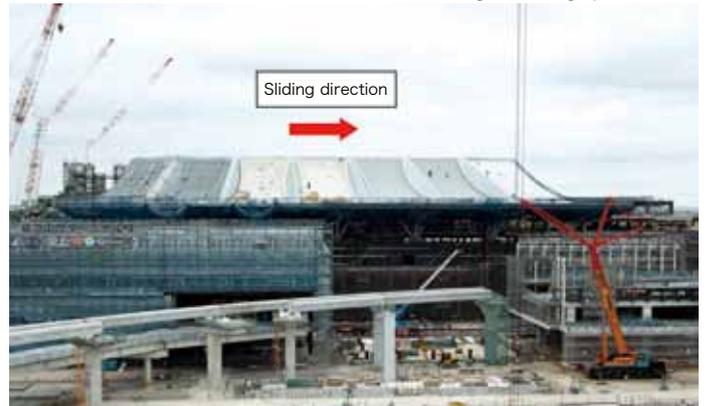
Photo 3 Seventh sliding
Under construction of metallic roof in 5 spans; installation of 5-row skylights

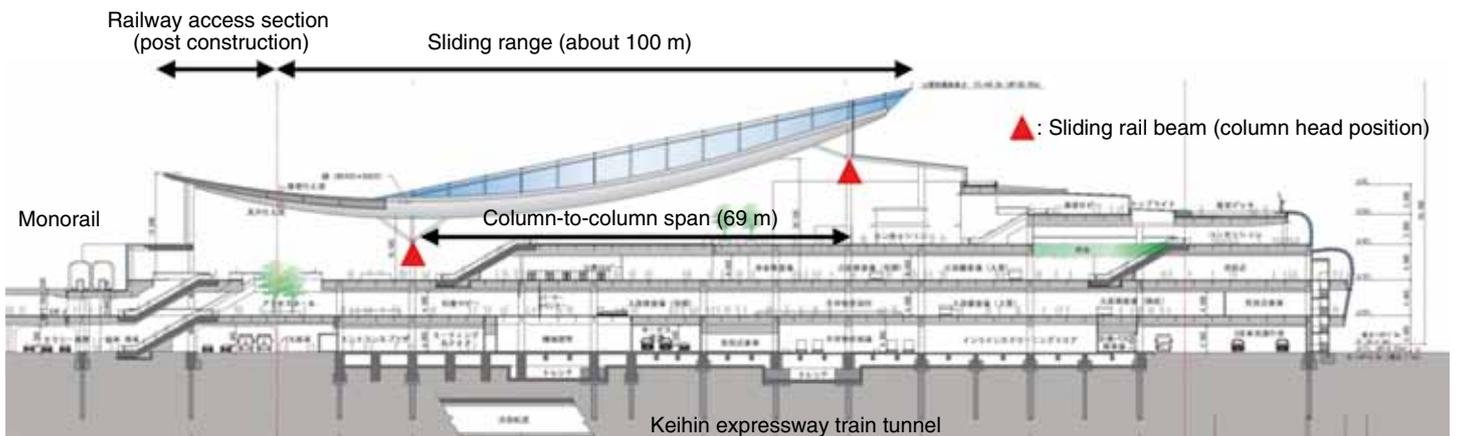
Fig. 1 Section of International Passenger Terminal Building

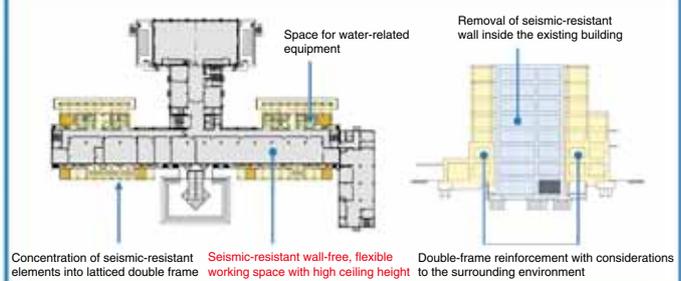
Plan and section after conversion

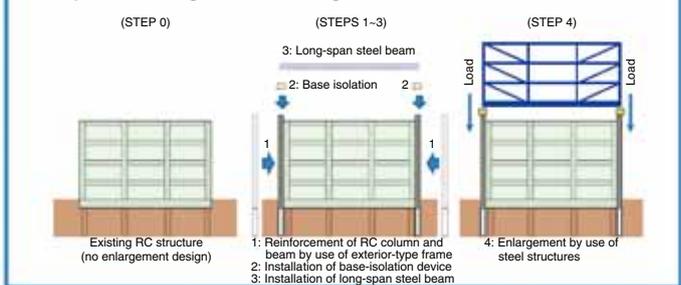
Conceptual drawing of new framing method

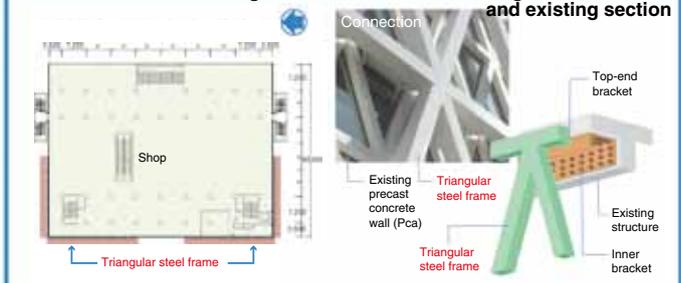
Plan of reinforcement range

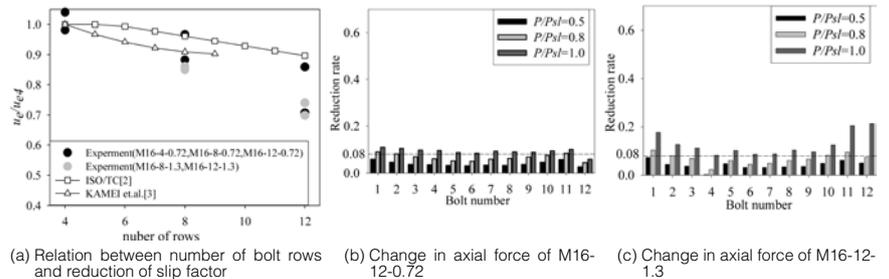
Fig. 1 Test Results

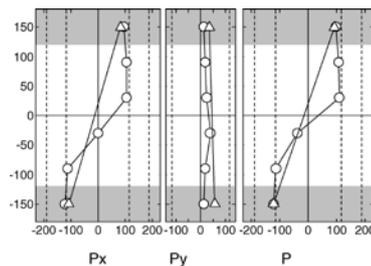
Fig. 2 B62-Dt22: Stress Distribution of Beam-web High-strength Bolt Joint at the Time of Maximum Yield Strength

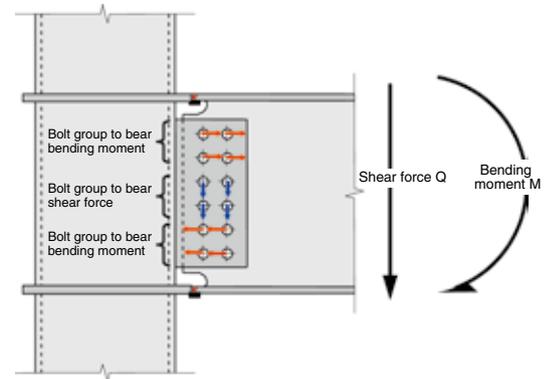
Fig. 3 Stress Condition of Beam-web High-strength Bolt Joint Assumed in the Current Design Method

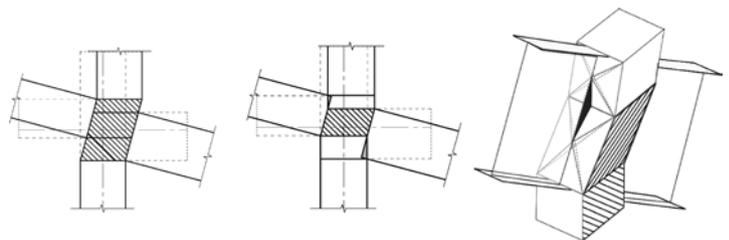
Fig. 2 Various Collapse Mechanisms of Offset Panels

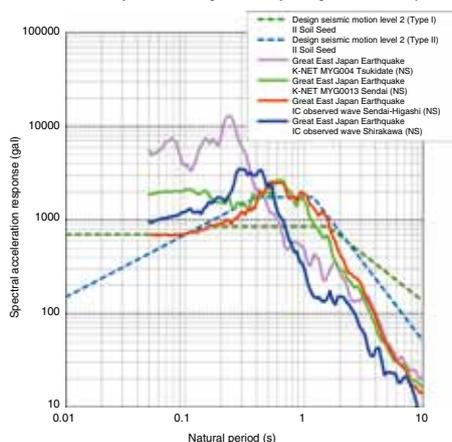
Fig. 2 Comparison of Spectral Acceleration Responses

Fig. 2 shows the spectral acceleration response of the current earthquake. While the seismic motion was comparatively large, structures suffered relatively little seismic damage. A major reason for this was the current earthquake was dominated by spectral acceleration with a short natural period of 0.3~0.5 seconds, compared to the natural period that commonly dominates buildings and public facilities. Another reason for less structural damage was the implementation of seismic reinforcements against great earthquakes that was carried out following the Great Hanshin Earthquake (1995). Among other features of the current quake were an extended vibration time and long-period seismic motion components exceeding 20 seconds.

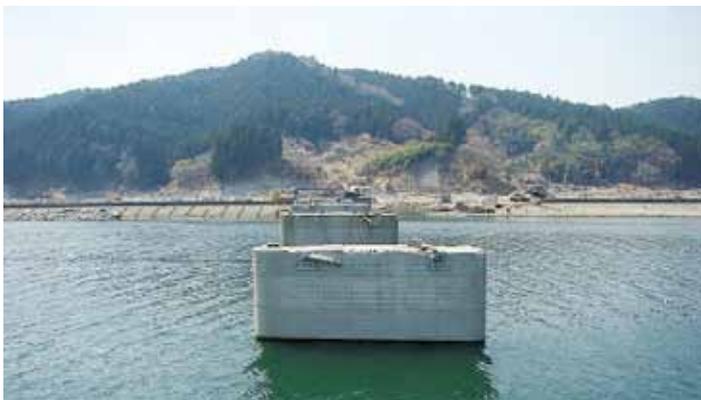
Photo 1 Washing away of superstructure

The Great East Japan Earthquake caused many incidences of great damage in which highway bridges installed in coastal areas or across rivers were washed away by the associated tsunami (Photo 1). But, then again, in areas where the tsunami height was confirmed to have exceeded that of a bridge's superstructure, many of these bridges were not washed away. In addition, there were cases in which the earthworks adjoined next to a bridge section were washed away by the tsunami, while the bridge structure itself remained in place (Photo 2). Currently, surveys and other research on the mechanism of tsunami-generated bridge damage are being promoted in many fields.

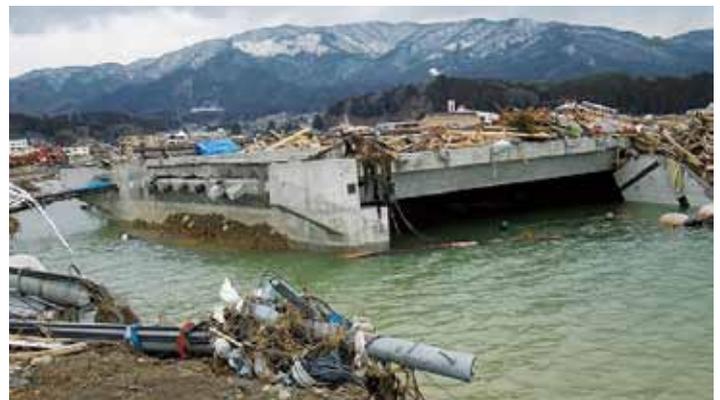
Photo 2 Washing away of earthwork in the front and rear of bridge

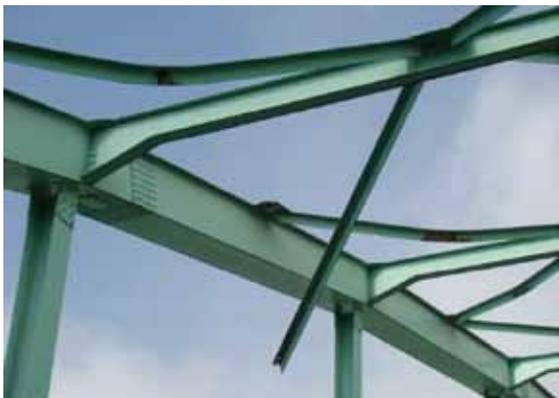
Photo 3 Damage of top lateral bracing of through Langer arch bridge

Highway Bridges (issued after 1996 in response to the Great Hanshin Earthquake of 1995) or reinforced based on those standards. On the other hand, in unreinforced bridges, damage such as the buckling and fracture of superstructures members was confirmed, as was damage to bridge piers and bearings (Photo 3), as observed in previous large-scale earthquakes. In addition, even when damage to a bridge structure was slight, there were many examples of level differences of the road surface produced by the sinking of back-filled soil of a bridge abutment inhibiting the quick recovery of traffic functions.

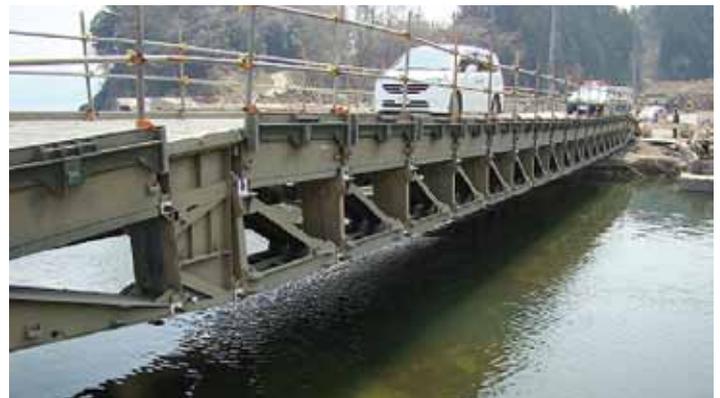
Photo 4 Emergency assembly bridge

Soon after the earthquake, efforts were made to secure emergency transport routes by repairing level differences of the road surface and restoring collapsed embankment, removing debris, and using emergency assembly bridges (Photo 4). Temporary bridges were installed in washed-out bridge sections and emergency restoration work was undertaken on damaged bridges. Currently, the main highway networks have nearly returned to normal operations, excluding those in tsunami- and radiation-ravaged areas. Studies and other work aimed at permanent recovery will be continuously pursued and accelerated.

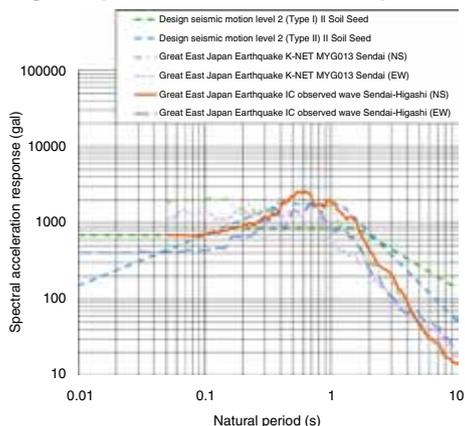
Fig. 1 Spectral Acceleration Responses

Fig. 1 shows the spectral acceleration responses associated with the Great East Japan Earthquake and recorded in the vicinity of the Sendai-Tobu elevated bridge of Sendai-Tobu Expressway. At the Sendai-Higashi interchange and K-NET Sendai where 6.2 was measured on the seismic intensity scale, the spectral acceleration response reached nearly the same level as the standard spectral acceleration response of design seismic motion level 2 (Type II) in the vicinity of a natural period of 1 second. Meanwhile, regarding the seismic motion observed on expressways, the peak spectral acceleration response was on the short natural period side (in the vicinity from 0.2 to 0.5 seconds) at many sites. The following introduces the damage and emergency restoration conditions of the Sendai-Tobu elevated bridge that suffered damage characteristic to steel bridges.

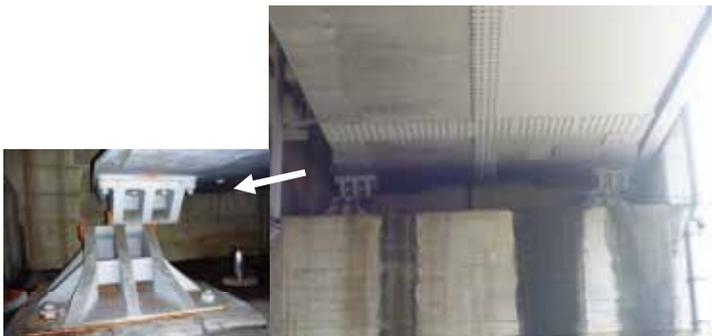
Photo 1 Damage of pin bearing and slippage of composite girder (Sendai Station terminal, Tohoku Shinkansen)

On the Tohoku Shinkansen super-express line, the collapse of electrification posts and elevated RC railway bridges and other types of damage occurred along a 500-km stretch from Omiya Station to Iwate-Numakunai Station. Photo 1 shows the damage inflicted on a pin bearing of the Kakyoin Bridge, a 73 m-long composite girder bridge located at the Sendai Station terminal. The pin fractured from the center. During the restoration work, the pin was used as it was, and the girder and the bearing were returned to their original position and a device was attached to restrict movement solely to the direction of the bridge's transverse axis. While a large aftershock occurred on April 7, the entire Tohoku Shinkansen line resumed operations on

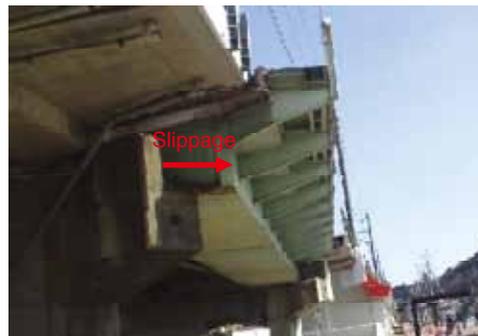
Photo 2 Slippage of skewed girders (Kashima Jingu Station, Kashima Line)

Existing railway lines also suffered damages in a wide area extending from the Tohoku region to the Kanto region. Photo 2 shows the slippage of a girder on the Dai-ichi-Kyuchu overbridge located at Kashima Jingu Station of the Kashima Line. The bridge is installed with a skew angle of about 60° at the composite girder of the box-girder section. While it was found that rotational behavior occurred due to the horizontal seismic motion of the skewed girder, the previous completion of girder seat expansion work prevented the bridge from collapsing. Most existing railway lines, excluding those in tsunami-damaged areas, resumed operations by the end of April 2011.

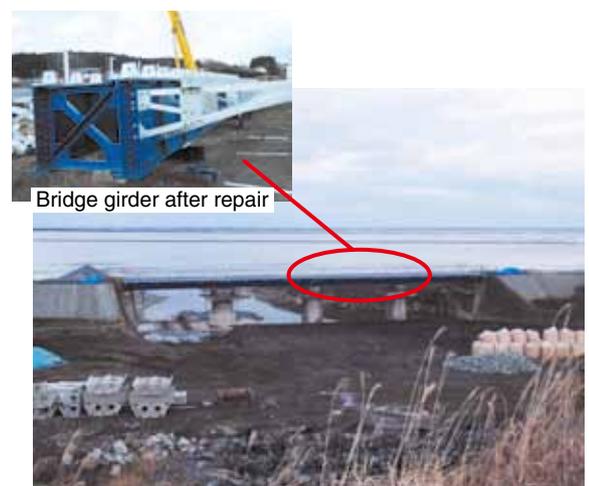
Photo 4 Installation of repaired girders (Ohamagawa Bridge on Hachinohe Line)

cilities, the Ohamagawa Bridge on the Hachinohe Line suffered only comparatively slight damage, while four 10-m spans of the deck steel plate girders were washed away by tsunamis (Photo 3), and thus it was decided that the bridge would continue in use, with some restoration work. While some of the structural members were replaced, most of the deformities in the girders were corrected by means of heating, and the girders were re-installed in their original position in December 2011 (Photo 4).

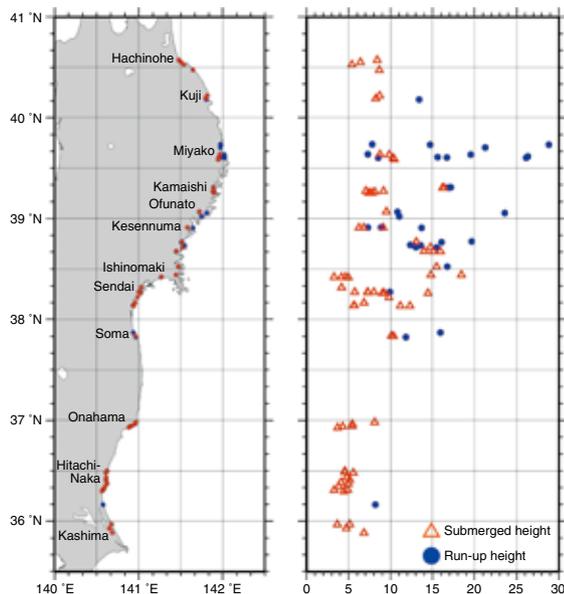
Fig. 1 Results of Surveys of Tsunami Height

Two major features punctuate the current earthquake: very strong seismic motion, as seen in the highest maximum acceleration ever recorded in the strong-motion earthquake observation in port and harbor areas, and seismic motions of long duration. In addition, because the tsunami waves that attacked the coast were larger in scale than forecasted in the design of disaster-prevention facilities, civil engineering and building structures, including port and harbor facilities, suffered serious damage. (Refer to Fig. 1 and Photo 1)

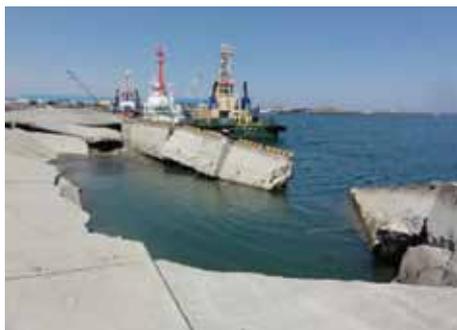
Photo 2 Collapse of sheet-pile-type quaywall

A characteristic type of damage found in steel port and harbor structures after the current earthquake is the disruption of interlock-

ing joints of steel sheet piles of sheet-pile-type quaywalls, causing the collapse of the quaywalls (Photo 2). The cause of the collapse is thought to be the uplifting forces and hydraulic forces that acted on portions damaged by seismic forces occurring in the steel sheet piles and apron pavement. This damage can be defined as typical of disasters caused by complex earthquake-tsunami events.

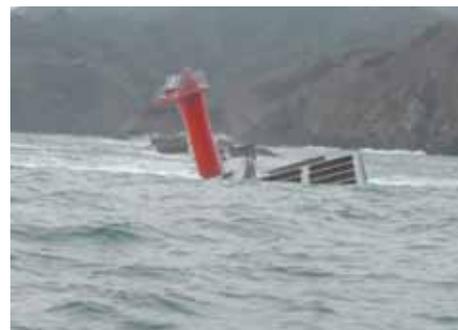
Photo 3 Collapse of breakwater installed for tsunami disaster prevention

Further, in the current earthquake, not only the existing breakwaters at Hachinohe, Kuji, Miyako and Soma Ports suffered tsunami damage, but the breakwaters installed at the mouths of Kamaishi and Ofunato Ports to prevent tsunami damage also suffered greatly (Photo 3).

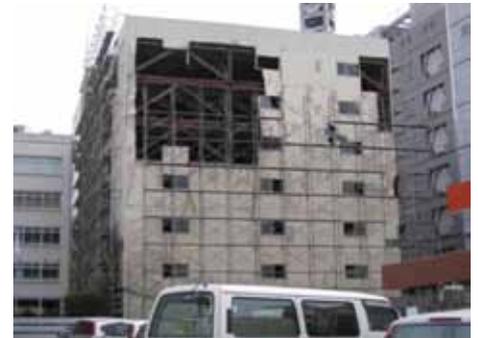
Photo 1 Falling of non-structural members

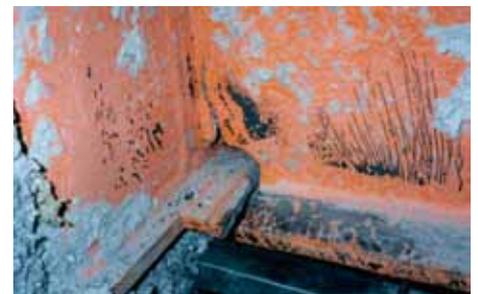
Photo 2 Example of beam-end flange fracture that occurred in a great number in the Great Hanshin Earthquake

Visual surveys conducted on steel-structure buildings in Sendai City, Miyagi Prefecture—located relatively near the epicenter—found almost no serious damage such as building collapses, only instances of slight damage such as fallen non-structural members (Photo 1). Damage to building structures was of the standard type, such as the breakage of exposed column bases and the buckling and fracture of braces. While brittle fractures are known to have occurred in the vicinity of beam-end web scallops in steel-structure buildings during the Great Hanshin Earthquake of 1995 (Photo 2),

there has been almost no confirmation of such damage in the Great East Japan Earthquake. This may be because, according to the survey results, these brittle fractures are regarded as being nearly non-existent.

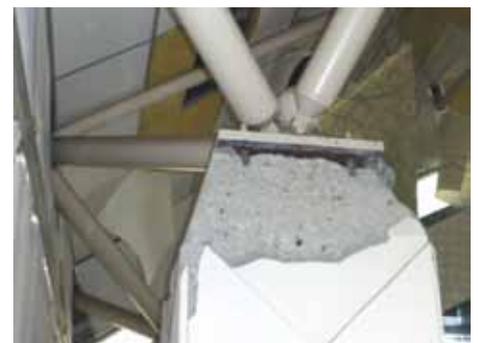
Photo 3 Damage of bearing

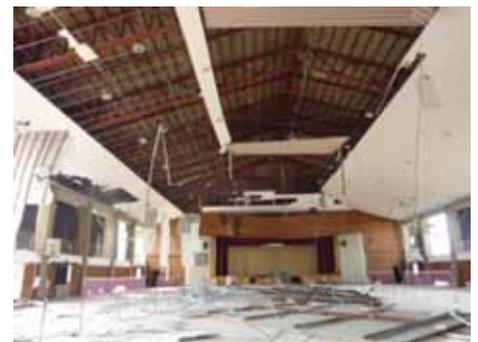
Photo 4 Falling of ceiling

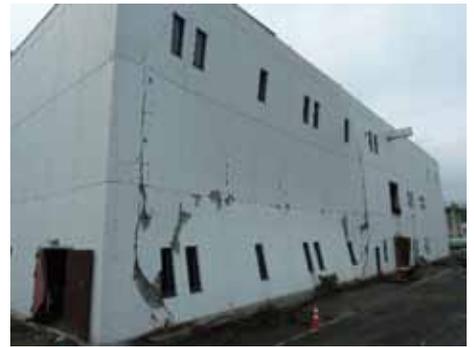
Photo 5 Yielding mechanism formed on RC wall

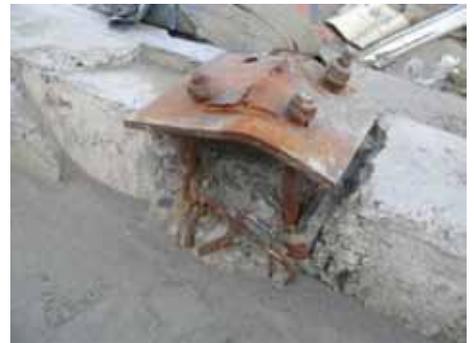
Photo 6 Fracture of column base weld

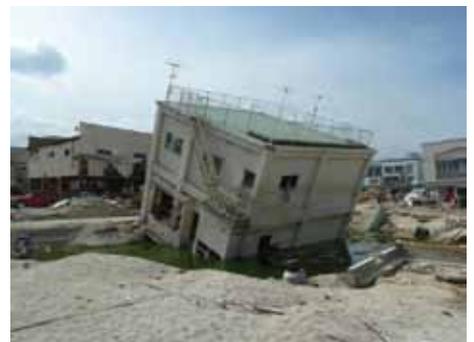
Photo 7 Inclination of RC-structure building due to scouring

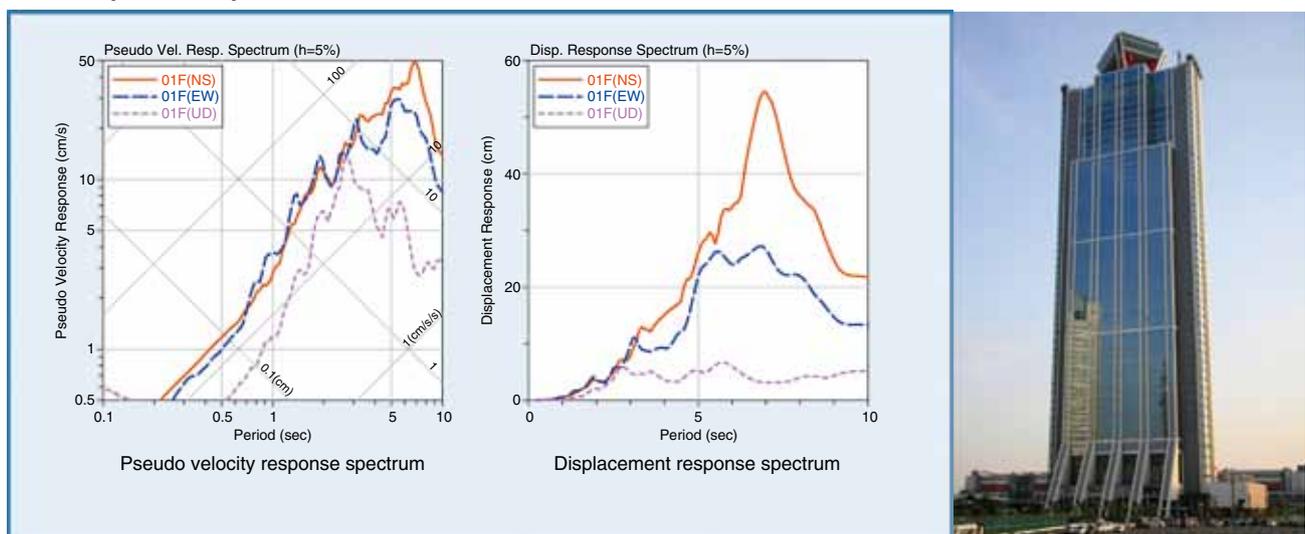
Fig. 2 Response of High-rise Steel-structure Building in Osaka in Long-period Seismic Motion in Great East Japan Earthquake³⁾

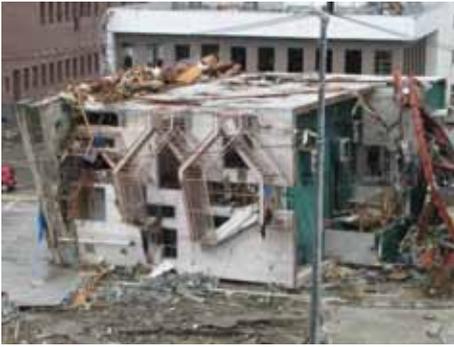
Photo 8 Overturning of steel-structure building due to floating

building, and thus rarely suffered overturning caused by interaction with buoyancy (Photo 8). The collision of drifts with buildings could be observed from the residual deformation seen in steel columns (Photo 9).

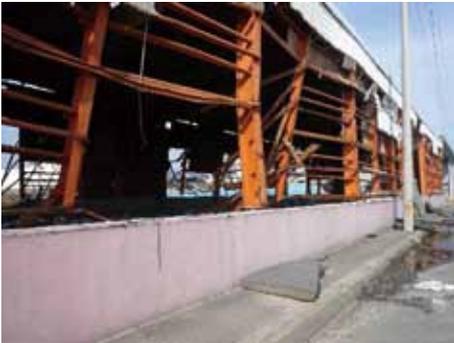
Photo 9 Damage due to collision by drift

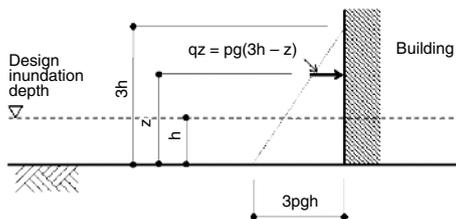
Fig. 3 Calculation Method for Tsunami Wave Pressure in the Guidelines of Cabinet Office⁵⁾

The *Guidelines for Tsunami Refuge Buildings* prepared by the Cabinet Office⁵⁾ prescribes tsunami wave pressure (Fig. 3). In the *Guidelines*, an expedient is proposed in which virtual static water pressure is three times the height of the design inundation depth and is assumed to work only on one side of a building. By verifying buildings damaged by the tsunami that was generated by the recent earthquake, the value of 3 shown in the expedient was found to actually be around 0.6 to 1 times⁶⁾ (Fig. 4). This seems to be attributable to the construction of breakwaters; and, even in cases when a breakwater was partially broken, it effectively worked to reduce the tsunami wave flow velocity.

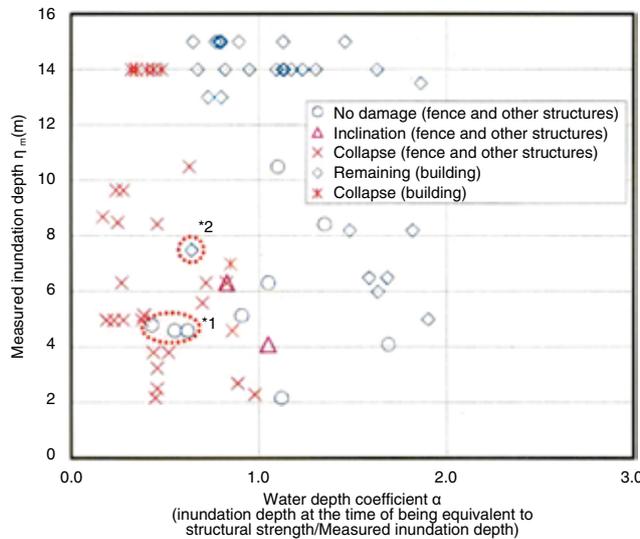
Fig. 4 Numerical Values Indicating Tsunami Loading Effect Obtained by Back Calculation from On-site Survey Data⁶⁾

In the newly proposed provisional *Guidelines*⁶⁾, even in cases when the effect of the breakwaters mentioned above might be expected, a value two times the inundation depth was finally shown. Although a value of two times inundation depth has sufficient allowance, this value was proposed by taking into account the indeterminacy of the tsunami run-up simulation that determines the hazard map (map of assumed inundation depths). Because of this, improvements in analytical technology are strongly called for.

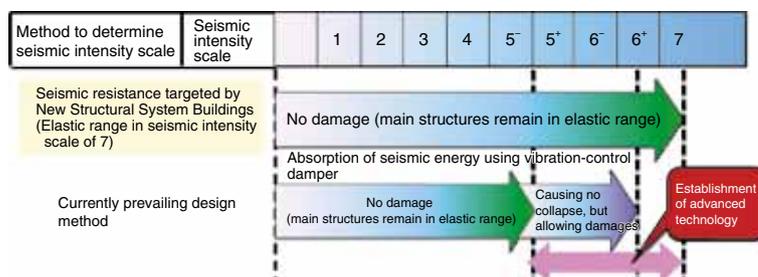
Fig. 2 Seismic Resistance of New Structural System Buildings

Classification to 10 scales based on the seismic intensity measured by seismometers (Japan Meteorological Agency)

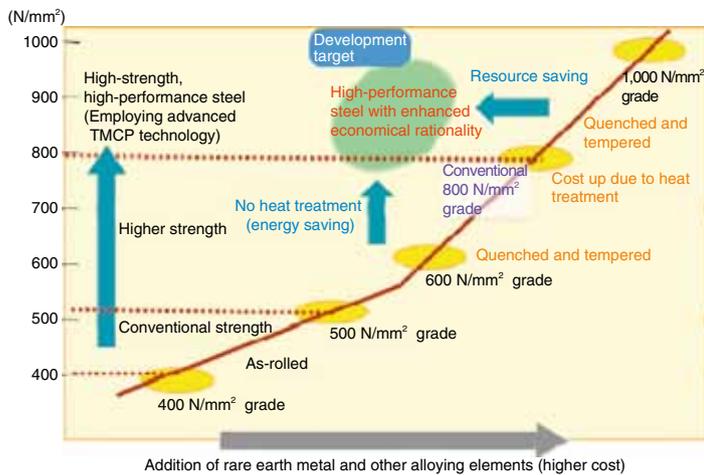
Fig. 3 Economical Rationality in Development of New High-strength Steel

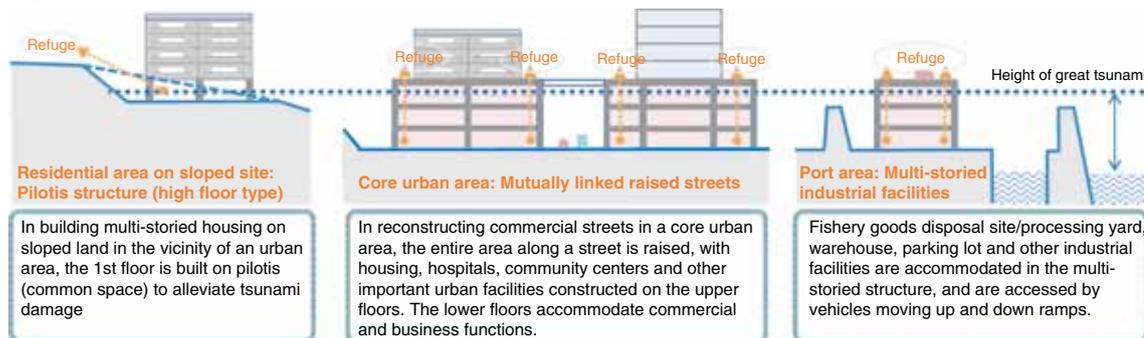
Fig. 4 Role of New Structural System Buildings in the Reconstruction of New Town

The new structural system buildings are damage-resistant, have a long service life, support variable inner applications, and, further, allow the free addition or removal of structural members. These buildings go beyond conventional building concepts in creating distinct urban buildings that incorporate some urban infrastructure. (Fig. 4)

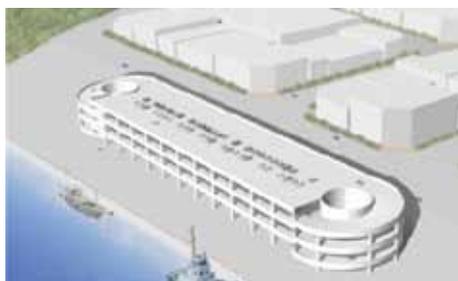
Fig. 5 Proto-type Model of Distribution Center

Distribution center with floors that are easily accessible by cars using two ramps: Mixed three-dimensional arrangement of plants and offices capitalizing on high ceilings and large spans—great advantages provided by New Structural System Buildings

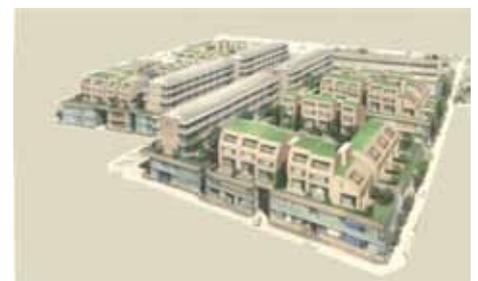
Fig. 7 Proto-type Model of Dense Urban Area

Redevelopment model for a dense urban area with dangerously inadequate disaster prevention features. Raised street area is developed using New Structural System Buildings in which the lower floors house existing commercial and business facilities and the upper floors accommodate multi-storied housing around a refuge square.
