STEEL CONSTRUCTION

TODAY & TOMORROW

“橋 (hashi)” in Japanese, or bridge in English

Bridges constitute the most important element of social infrastructure. This issue, No. 42, discusses the emerging trends in the design standards for bridges, the maintenance of steel highway and railway bridges, and the retrofitting of RC slab bridges to steel deck bridges.

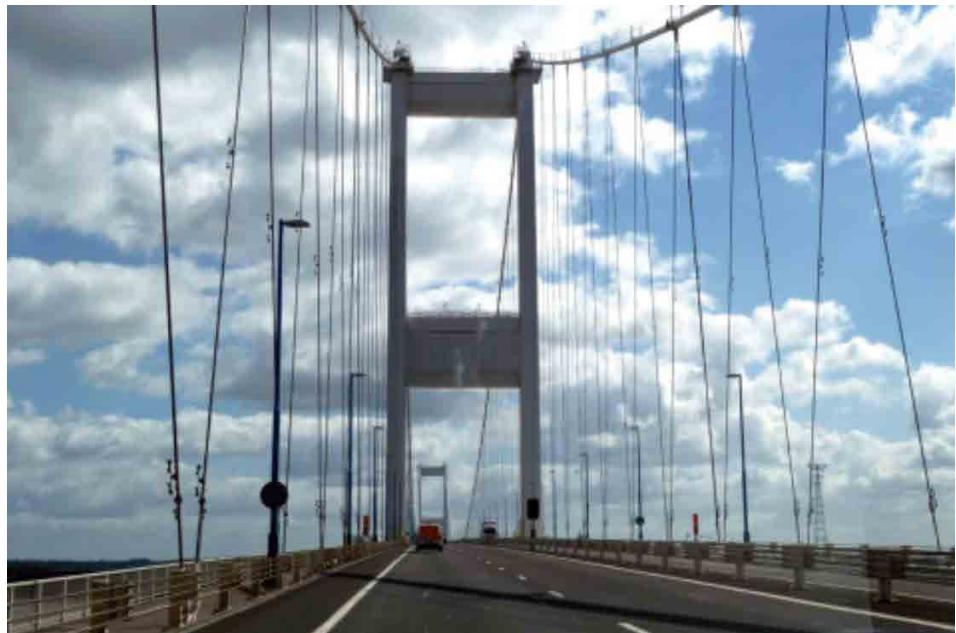
Photo 1 Severn Bridge

Severn Bridge is the suspension bridge crossing Severn River in southwest of U.K. Severn Bridge is called as Severn Crossing with Wye Bridge, Aust Viaduct and Beachley Viaduct which cross the boundary between England and Wales. Severn Bridge was opened in 1966. The bridge length is 1,600 m and main span length is 988 m (Photo 1). The box girder with stream-

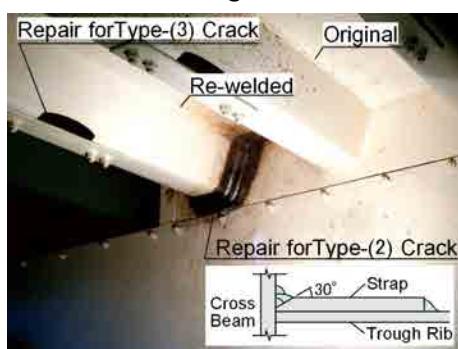
Fig. 5 Repair of Fatigue Cracks at Severn Bridge

In the field visit at Severn Crossing, we observed the condition of re-welded joints in the box girder and the condition of asphalt surfacing. We felt that the traffic volume was very little. The reason is that the traffic volume of about 70% may pass through Second Severn Bridge which was opened in 1996 at the downstream of Severn Bridge. Many patches by re-casting of asphalt surfacing which was re-cast in 1991 could be seen at the position of vehicle wheel (Photo 2). In the field visit inside the box girder, we observed the condition of re-welded joints between deck plate and trough rib, and also between trough rib and diaphragm, welded joints between bottom of trough rib and floatation diaphragm which had been repaired (Fig. 5).

For re-welding by three passes, it seemed that dispersion of weld size between deck plate and trough rib was smaller and their quality was better than the original. Welding repair with the metal backing plates had been carried out for the fatigue cracks at the cross section between trough rib and diaphragm. To repair the larger fatigue cracks at the welded joint between trough rib and floatation diaphragm, the bottom of trough rib was cut away partially and metal bypass materials were at-

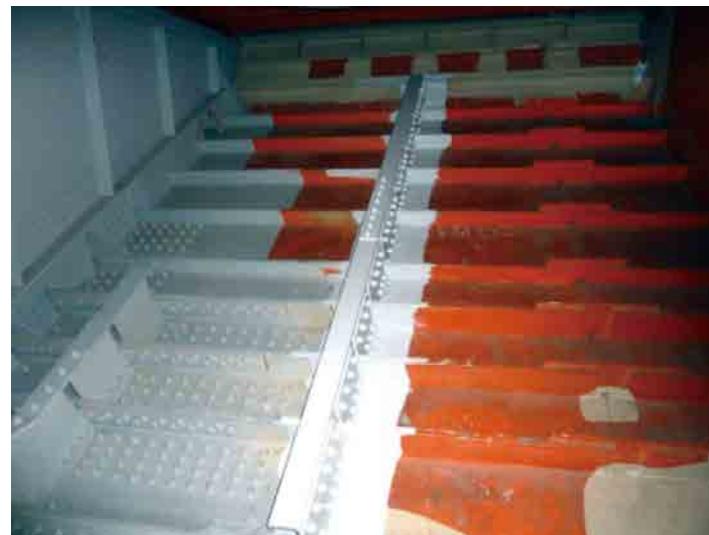
Photo 4 Reinforcement based on Merrison Report

the traffic volume is over 4,000 per day. It was clear that this bridge did not satisfy the criteria shown later by Merrison Report and reinforcing and re-strain of the cables were carried out from 1970's to 1980's and in 2004 (Photo 4). As orthotropic deck system in Erskine Bridge, thickness of deck plate is 12.7 mm and V-shaped rib is used as longitudinal rib of 5 mm thick. Surfacing is mastic asphalt of 38 mm thick as same as Severn Bridge.

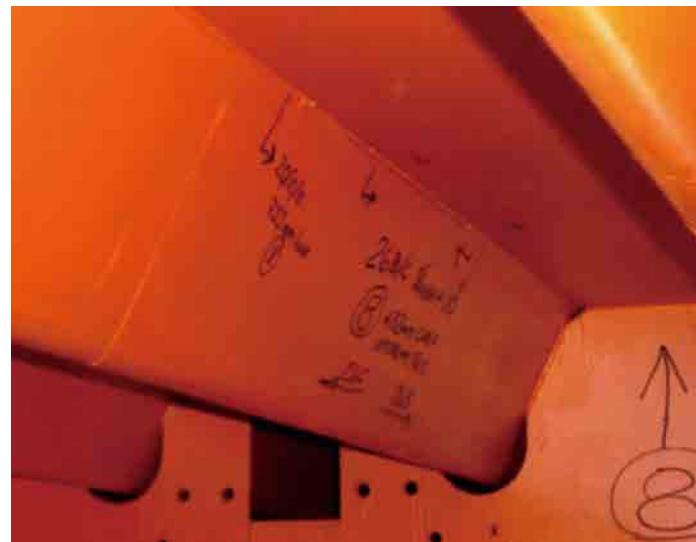
Photo 5 Bead-through crack at Erskine Bridge

Photo 5 shows the sample of crack which occurred at the weld bead which we call "bead-through crack." About ten bead-through cracks have been observed in this bridge and some of them have been repaired by cutting the edge of trough rib and re-welding by three passes as same as Severn Bridge. Although the length of the fatigue crack shown in Photo 5 is over 700 mm, the crack does not propagate toward the web of trough rib as the case observed in Japan. The reason seems to be that welding condition and cutting at the welded joint between deck plate and trough rib and dimension or stiffness of trough rib are different between the U.K. and Japan and so on.

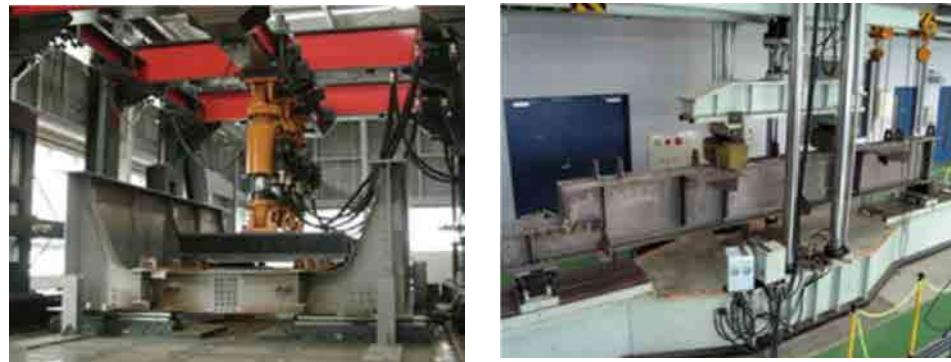
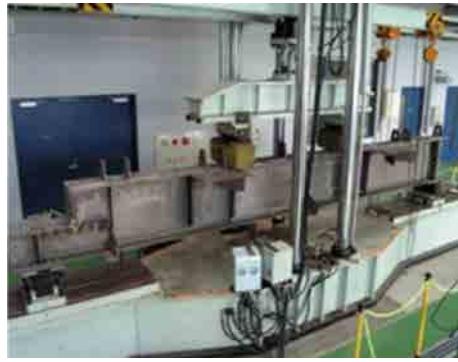
(a) Test for floor system
Photo 1 Fatigue testing condition

At the Komaki Research Laboratories, fatigue tests were conducted in the following two cases: one test using a steel bridge that was in service for more than 35 years following the startup of the Shinkansen and removed after installation of the new Shinagawa Station in the fall of 2003¹⁾; and another test using a large girder specimen that was in-

tentionally infused with blowholes (Photo 1). The test results for both the full-scale bridge specimen and the girder specimen satisfy the “Class D” designation prescribed in the fatigue design guidelines of the Japanese Society of Steel Construction and other organizations (Fig. 2). And the developed stress measured in all the steel bridges on the Tokaido Shinkansen falls below the Class D fa-

(b) Test for single main girder

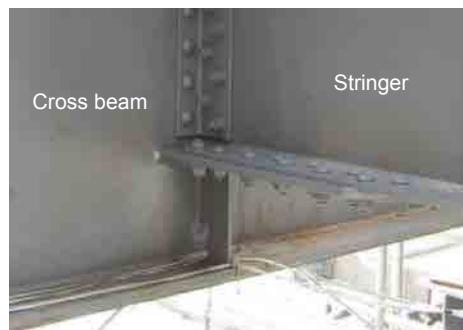
Photo 2 Floor system joint before and after provision of reinforcing measure

Next, we proposed a reinforcement method (Photo 2) to control the deformation behavior that caused the above-mentioned cracks. Specifically, static loading and fatigue tests were conducted using a full-scale test specimen of the floor system joints to which reinforcing members were attached. The effectiveness of the attachments was

(a) Before reinforcement

(b) After reinforcement

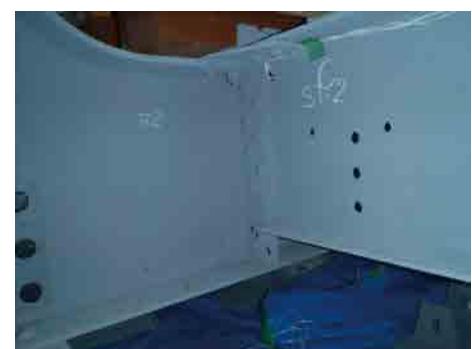
Photo 3 Reinforcement measure employing boat-shaped bracket (through plate girder)

To solve this problem, a static loading test was conducted to examine methods to reinforce the joints of stringers and cross beams. Then the reinforcing structure that was found to be most effective in reducing stress was selected. Specifically, it was confirmed that by attaching boat-shaped brackets and other reinforcing members to the floor system joints (Photo 3), the stress occurring at the three positions shown in Fig. 6 can be reduced.

(a) Before reinforcement

(b) After reinforcement

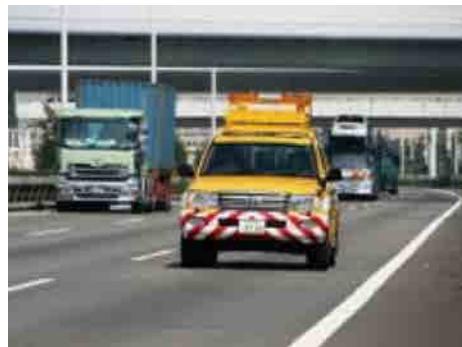
Photo 1 Patrol inspection (confirmation of structural condition using a patrol vehicle while running on the expressway)

A routine patrol inspection is shown in Photo 1, a close-range walking inspection in Photo 2, a close-range periodic inspection in Photo 3, and an instrumental inspection in Photo 4.

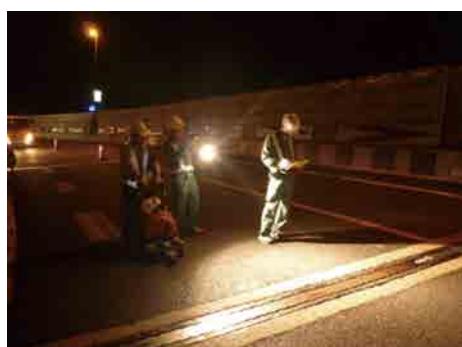
Photo 2 Walking inspection (walking inspection of structures by inspectors in areas of restricted traffic flow during nighttime)

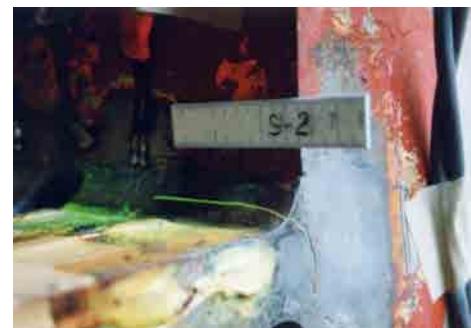
Photo 5 Occurrence of fatigue cracking (observed in weld line where beam and column cross)

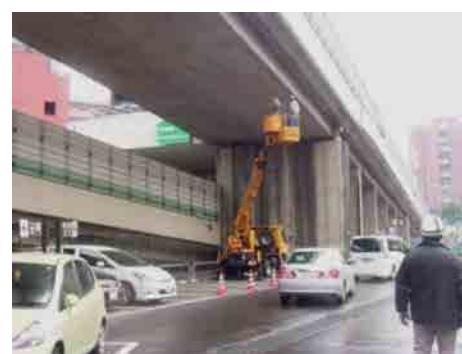
Photo 3 Close-range inspection (inspection by cherry picker; daytime inspection is available at sites where traffic flow is not adversely affected)

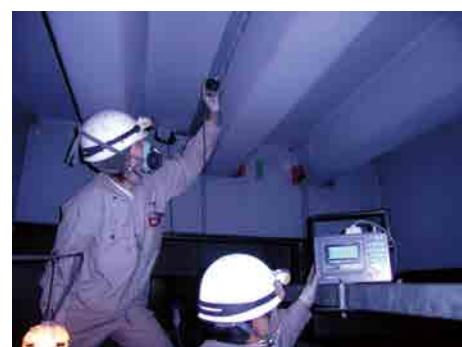
Photo 4 Instrumental inspection (ultrasonic testing of welds of steel structures)

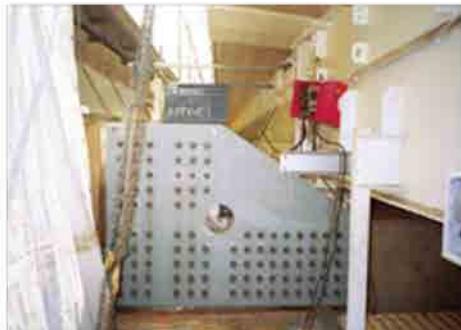
Photo 6 Reinforcement of steel bridge pier by splicing steel plate to pier

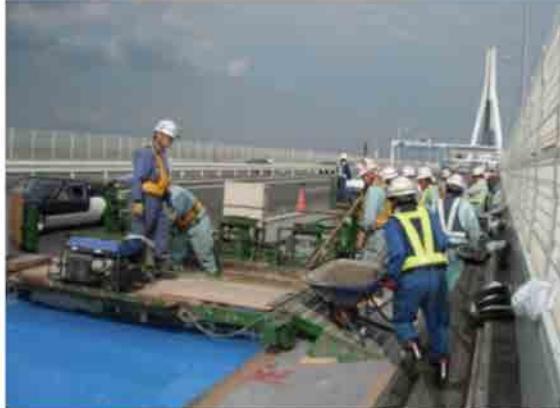
cracks, a method has been adopted that uses steel fiber-reinforced concrete (SFRC), having a larger elastic modulus than asphalt pavement, to suppress by means of the rigidity thus obtained the strain that occurs in steel deck welds and trough ribs.

Photo 7 Provision of countermeasure for fatigue in steel deck by means of SFRC paving (blue section: epoxy resin)

Photo 7 shows the SFRC placement and the pavement structure used by this method.

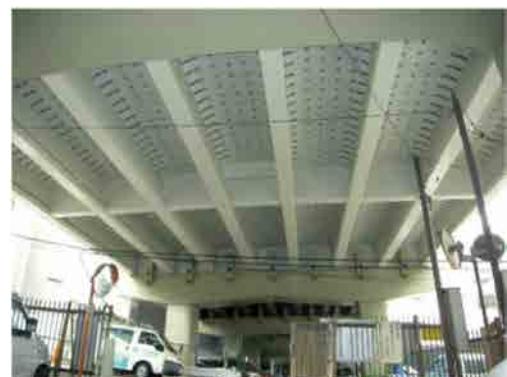
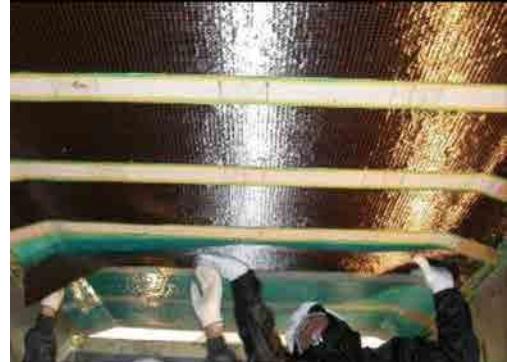
Photo 8 Reinforcement of RC slab with carbon-fiber sheet (sheet is pasted in the direction rectangular to slab; coating is provided to prevent deterioration of epoxy resin)

Photo 8 shows an RC slab that is reinforced by a carbon-fiber sheet that was pasted to the rear of the slab and then painted, and the reinforcing work underway.
