Durability Assessment of Various Kinds of Construction Materials by Means of Long-term Exposure Tests

—Durability Assessment by Means of Exposure Tests at Okinotorishima and Suruga Bay—

Research Group on Corrosion Protection and Durability of Offshore Steel Structures Committee on Overseas Market Promotion

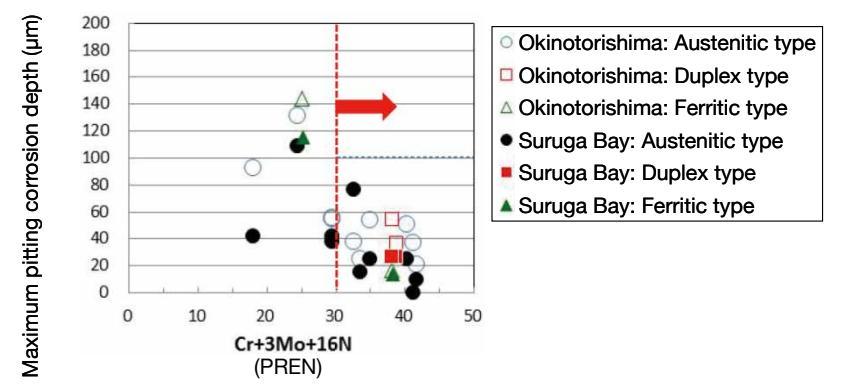
Fig. 2 Relationship between Maximum Pitting Corrosion Depth at General Section of Stainless Steel and PREN

The maximum pitting corrosion depth at the general section of all specimens (maximum value of respective specimens) was organized using the pitting resistance equivalent number (PREN: Cr+3Mo+16N; Cr, Mo and N: mass %), as shown in Fig. 2, and it was learned from these results that there was a correlation between the maximum pitting corrosion depth and the PREN. Further, crevice corrosion occurred at the insulation washer-specimen gap, and it was confirmed that there was a correlation between the maximum crevice corrosion depth at the insulation washer-specimen gap and the PREN (refer to Fig. 3).

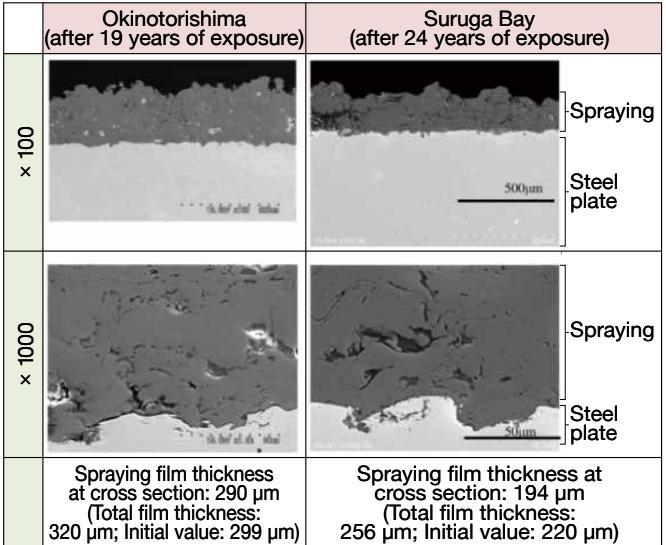
Fig. 7 SEM Images at Cross Sections of Aluminum-sprayed Plates

nized layer remained even after 24 years of exposure at Suruga Bay. Fig. 6 shows an SEM image of the cross section of zinc-aluminum alloy-sprayed plate (D-03), and Fig. 7 that of aluminum-sprayed plate (D-04). As for both of the zinc-aluminum alloy-sprayed plate and the aluminum-sprayed plate, while the formation of corrosion products was observed, the sprayed layer remained, and thus it is assumed that these plates had sound corrosion-protection performance. Meanwhile, regarding the zinc-aluminum alloy-sprayed plate, because corrosion products occurred at the exposed specimen at Suruga Bay, the sprayed film thickness increased over that at Okinotorishima. Regarding the aluminum-sprayed plate, while the film thickness increased due to corrosion products at Suruga Bay and Okinotorishima, no difference of the increase in film thicknesses between both testing sites was found.

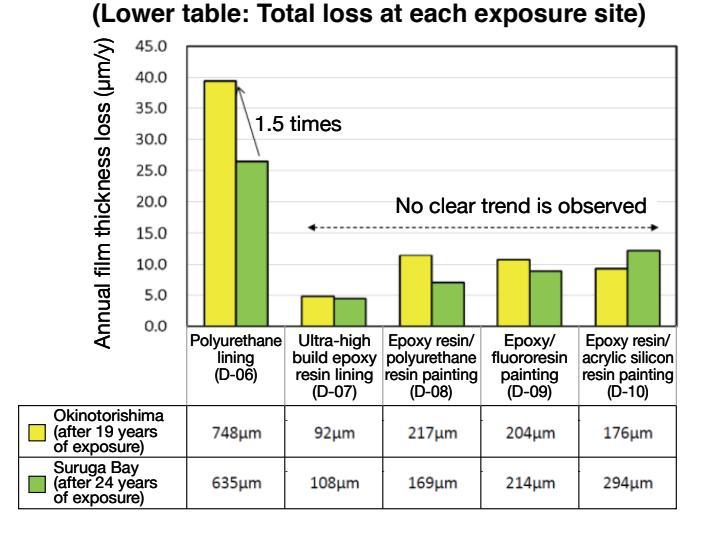
Fig. 8 Loss of Film Thickness of Organic-lined and Heavy-duty Painted Plates

Fig. 8 shows the annual film thickness loss obtained by dividing the lined/coated/painted layer loss that was found from the difference between the initial film thickness and the film thickness after exposure by the number of years of exposure. In the polyurethane-lined plate in which the loss was highest, the loss at Okinotorishima was larger by about 50% than that at Suruga Bay, which coincided with the ratio of sunshine radiation between both testing sites. The loss in other lined/coated/painted plates was larger at Okinotorishima, but the loss in the epoxy resin/acrylic silicon resin-painted plate was larger at Suruga Bay.

primer coating, the annual average film thickness loss rate of lined/coated/painted plates is shown in Fig. 8. Fig. 9 shows the surface appearance of heavy-duty painted plate. In the figure, the surface where top coating was completely lost can be seen for respective heavy-duty-painted plates at both testing sites.

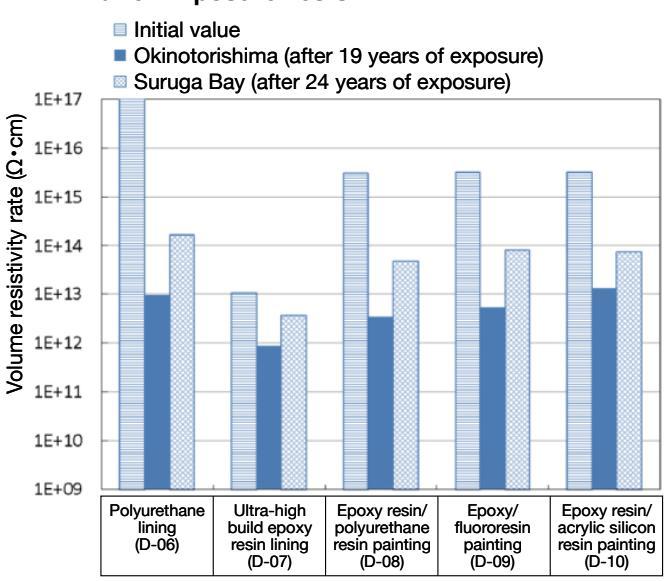
Fig. 10 Insulation Resistance (Volume Resistivity) of Organic-lined and Heavy-duty Painted Plates after Exposure Tests

Fig. 10 shows the results of the measurement of insulation resistance (volume resistivity). A high insulation resistance of $10^{10} \Omega \cdot \text{cm}$ or higher was observed at both testing sites, but the insulation resistance of every specimen at Suruga Bay was higher than that at Okinotorishima, and as a result, it is supposed that the deterioration of the lined/coated/painted film was more severe at Okinotorishima.

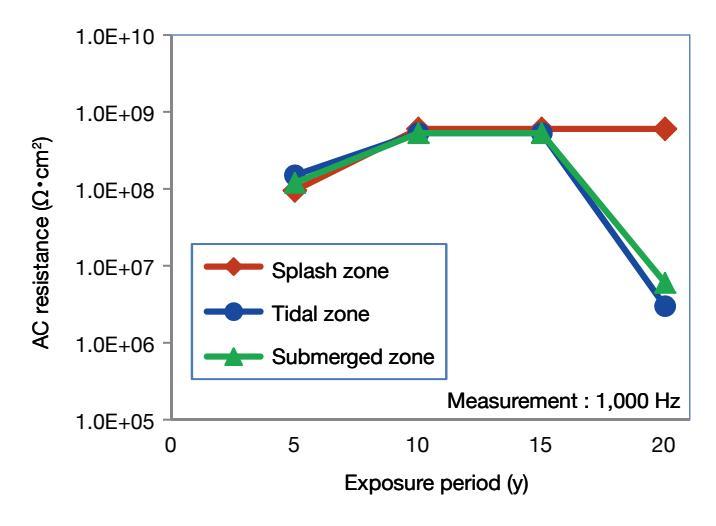
Fig. 13 Secular Changes of AC Resistance of General Painted Specimens

passed 15 years, the film thickness abruptly decreased. Meanwhile, because the adhesive strength was measured by selecting a sound section, its abrupt deterioration was not observed even after 20 years of exposure.

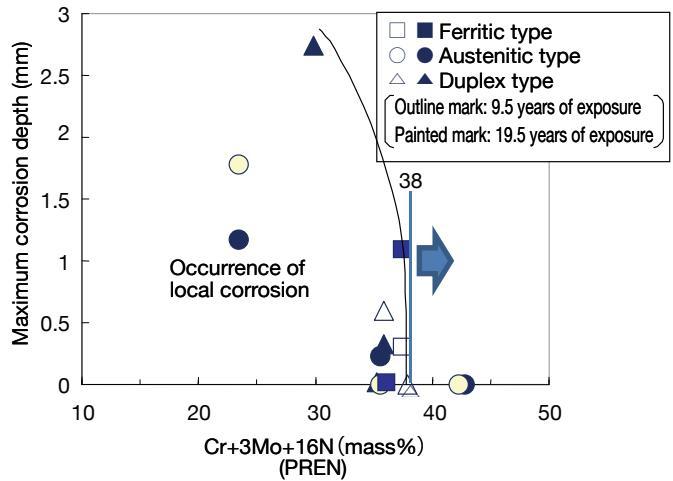
Fig. 14 Relationship between Maximum Corrosion Depth of Stainless Steel-lined Specimen and PREN (Tidal Zone to Submerged Zone)

The main corrosion of stainless steel was local corrosion centering on the crevice corrosion that occurred beneath the large marine organism-adhered section in the tidal to submerged zones. The local corrosion in the splash zone was pitting corrosion, and the level of pitting corrosion in the splash zone was considerably slighter than that in the tidal-submerged zones. Fig. 14 shows the relationship between the stainless steel composition and the maximum corrosion depth in the tidal-submerged zones where corrosion developed. As the pitting resistance equivalent number (PREN: Cr+3Mo+16N; Cr, Mo and N: mass %) became larger, the maximum corrosion depth tended to become smaller, and when the PREN surpassed 38, pitting corrosion did not occur in highly corrosion-resistant stainless steel.

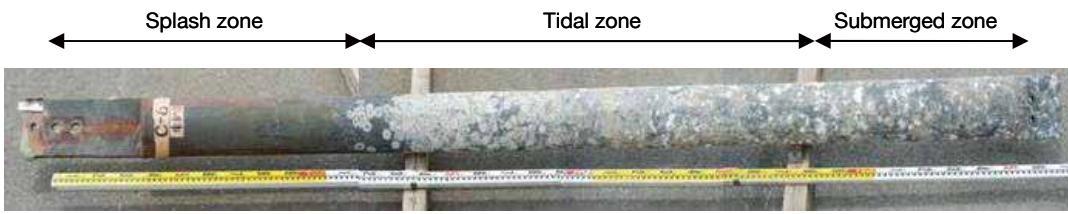
Photo 5 Appearance of Urethane Elastomer-lined Specimen after 23 Years of Exposure

Photo 5 shows the appearance of the urethane elastomer-lined specimen after 23 years of exposure. While rust stains were observed, cracking and peeling were not observed, and thus sound condition was maintained. Fig. 17 shows the secular change of AC resistance in the splash zone. It was seen from the figure that a high resistance of $10^8 \,\Omega \cdot \text{cm}^2$ or more was maintained over the long term. Further, it was confirmed from the section-wise measurement results for the specimen raised from the testing site that there was no difference in deterioration conditions between the tidal and submerged zones. Also, no considerable loss of film thickness due to the lapse of exposure years was observed. To these ends, it was found that corrosion-protection performance was maintained for urethane elastomer-lined specimens.

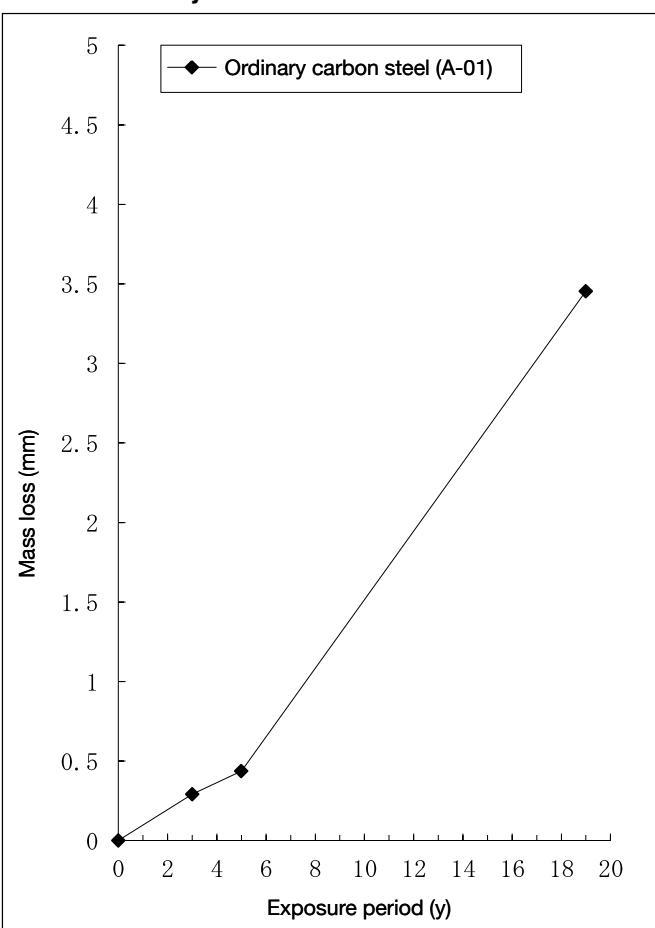
Fig. 1.1 Secular Changes of Mass loss: Ordinary Carbon Steel

• The corrosion rate in the 5th year of exposure was 0.087 mm/y and that up to the 19th year of exposure was 0.182 mm/y, which meant that in terms of calculation, the corrosion rate in the 5th year of exposure increased to about twice that in the 19th year of exposure.

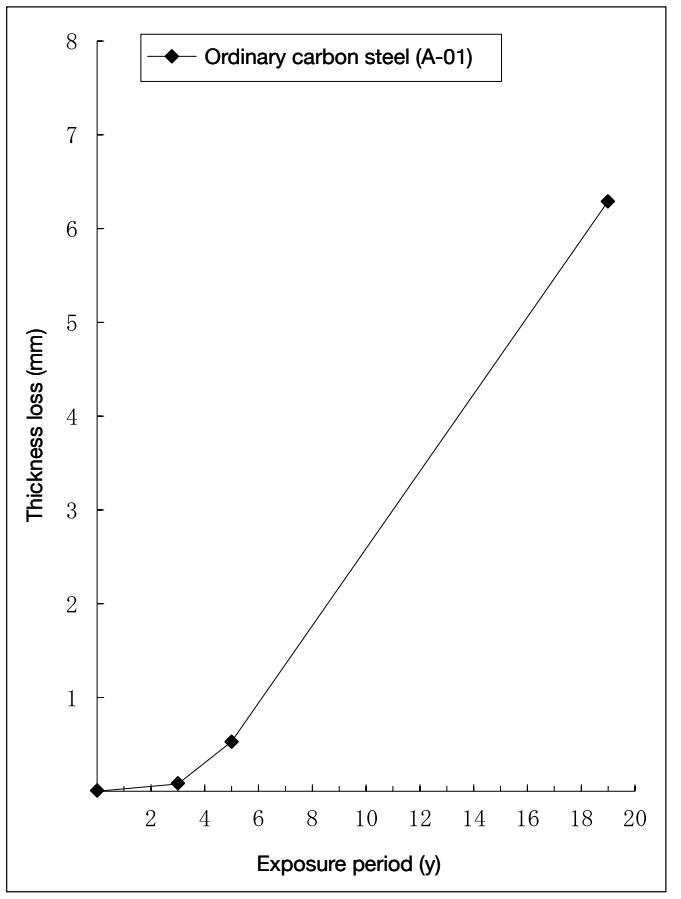
Fig. 2 Secular Changes of Plate Thickness Loss: Ordinary Carbon Steel

• Because measurement was not conducted on the identical section in which the initial thickness was measured, negative values were observed, and thus the relative comparison between thickness loss and weight loss was difficult to conduct.

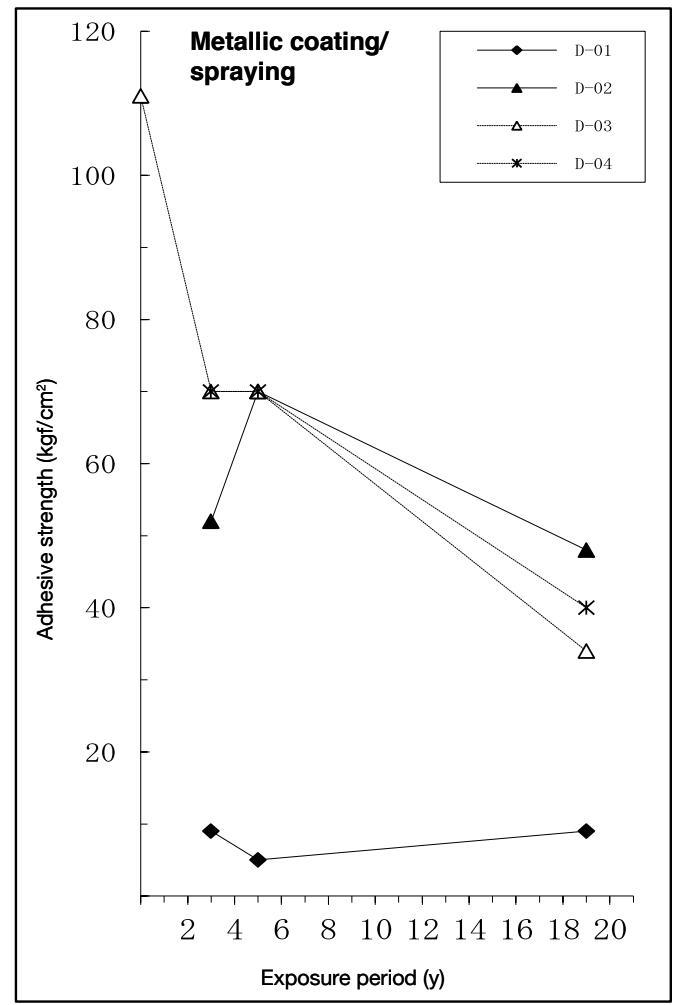
Fig. 5.1 Secular Changes of Adhesive Strength: Metallic-coated/sprayed Plates

- As for the aluminized stainless steel plate (D-01) and hot-dip galvanized plate (D-02), the metallic coating film peeled off from the adhesive-applied adhered surface (referred to as "adhered surface"). In D-01, because of the probable lack of adhesive strength between the adhered surface and the aluminized surface, the peeling strength was low, at 3~5 kg/cm².
- As for the zinc-aluminum alloy-sprayed plate (D-03) and aluminum-sprayed plate (D-04), the spraying film peeled off from the adhered surface at a high level of peeling strength over the limit of the measurement instrument (70 kg/cm²). This high peeling strength was assumed to be attributable to the fact that the adhesive penetrated into the porous sprayed film and as a result the apparent peeling strength increased.

• As for the aluminized stainless steel plate (D-01), zinc-aluminum alloy-sprayed plate (D-03) and aluminum-sprayed plate (D-04), because the coating/spraying film fractured at the interface between the adhered surface and the coating/spraying layer, it was impossible to correctly measure the adhesive strength between the coating/spraying film and the steel surface. As for the hot-dip galvanized plate (D-02), while partial cohesion fracturing of the film was observed, the coating layer nearly disappeared, and thus it was impossible to correctly measure the adhesive strength between the coating film and the steel surface.

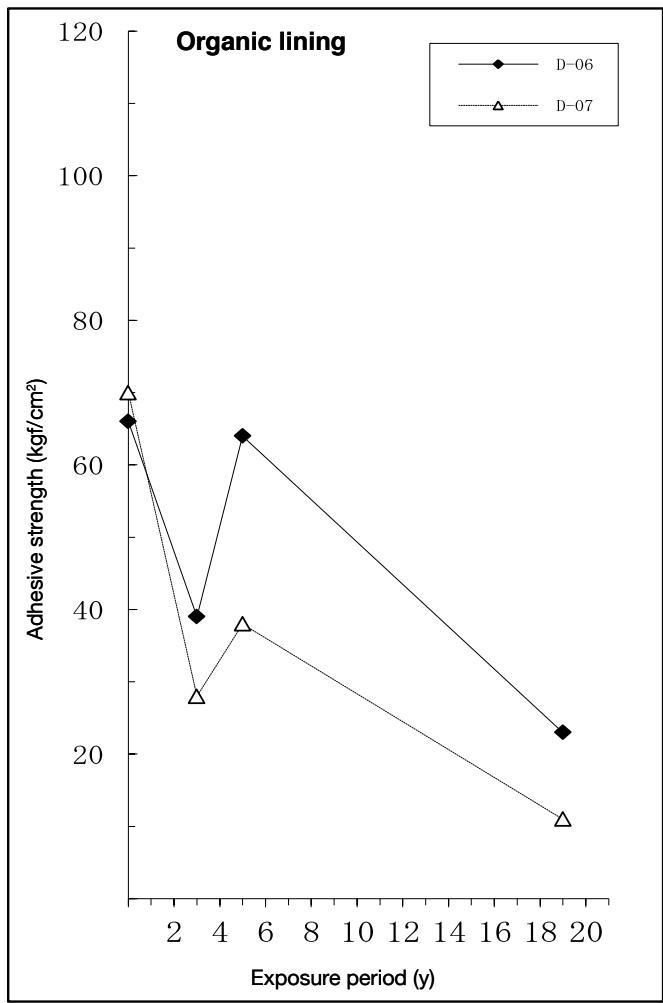
Fig. 5.2 Secular Changes of Adhesive Strength: Organic-lined Plates

- As for the polyurethane-lined plate (D-06), there was nearly no change between the initial adhesive strength (66 kg/cm²) and that after 5 years of exposure. The lining film peeled off from the adhered surface.
- As for the ultra-high build epoxy resin-lined plate (D-07), the adhesive strength lowered from the initial value (70 kg/cm² or more) to about half (28~38 kg/cm²) due to exposure. The peeling type was of the steel interface peeling or mixed peeling of peeling from the adhered surface+cohesion fracture within the film (cohesion fracture).
- Only the polyethylene-lined plate (D-05) was subjected to the peeling test. There was absolutely no change between the initial value (18 kg/cm²) and the value after 5 years of exposure.

• As for the polyurethane-lined plate (D-06), because the lining film fractured at the interface between the adhered surface and the polyurethane layer, it was impossible to correctly measure the adhesion strength between the lining film and the steel surface. As for the ultra-high build epoxy resin-lined plate (D-07), it was observed that the adhesive strength lowered from the initial value. This lowering was caused by the cohesion fracture of the lower layer, and it was further considered that the lowering was caused by the deterioration of lining material itself.

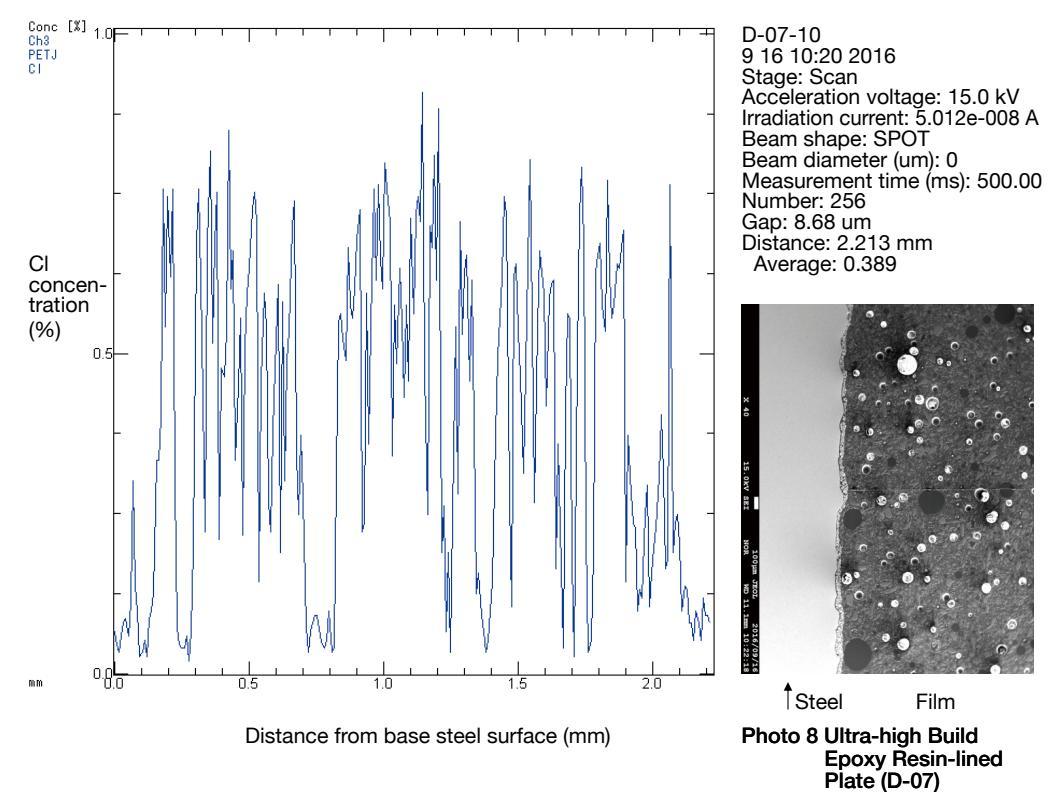
Fig. 3 EPMA Analytical Results for CI Concentration: Ultra-high Build Epoxy Resin-lined Plate (D-07)

• As for the polyethylene-lined plate (D-05) and polyurethane-lined plate (D-06), Cl concentration on the lining film showed almost no change before and after exposure. As for the ultra-high build epoxy resin-lined plate (D-07), Cl concentration after 5 years of exposure was slightly higher than that before exposure, but the deviation in the measured results was large and also the cause was not clear. As for the epoxy resin/polyurethane resin-painted plate (D-08) and epoxy/fluororesin-painted plate (D-09), no difference of Cl concentration before and after exposure was observed. As for the epoxy resin/acrylic silicon resin-painted plate (D-10), when compared to the sample before exposure, the Cl concentration tended to show a higher level at probably both the top coating acrylic layer and the epoxy layer under the acrylic layer after 5 years of exposure.

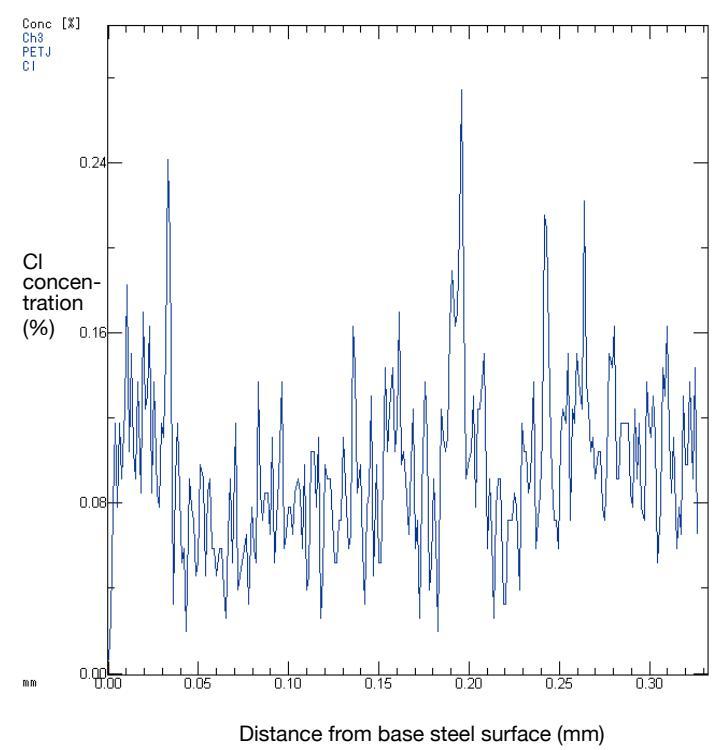
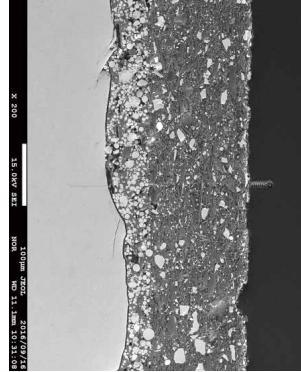
Steel Film Photo 9 Epoxy Resin/ Polyurethane Resinpainted Plate (D-08)

As for both the epoxy resin/polyurethane resin-painted plate (D-08) and epoxy/fluororesin-painted plate (D-09), it was seen that a trace amount of chlorine uniformly existed in the painting film. However, it could not be judged whether or not the existence of chlorine was caused by external factors.

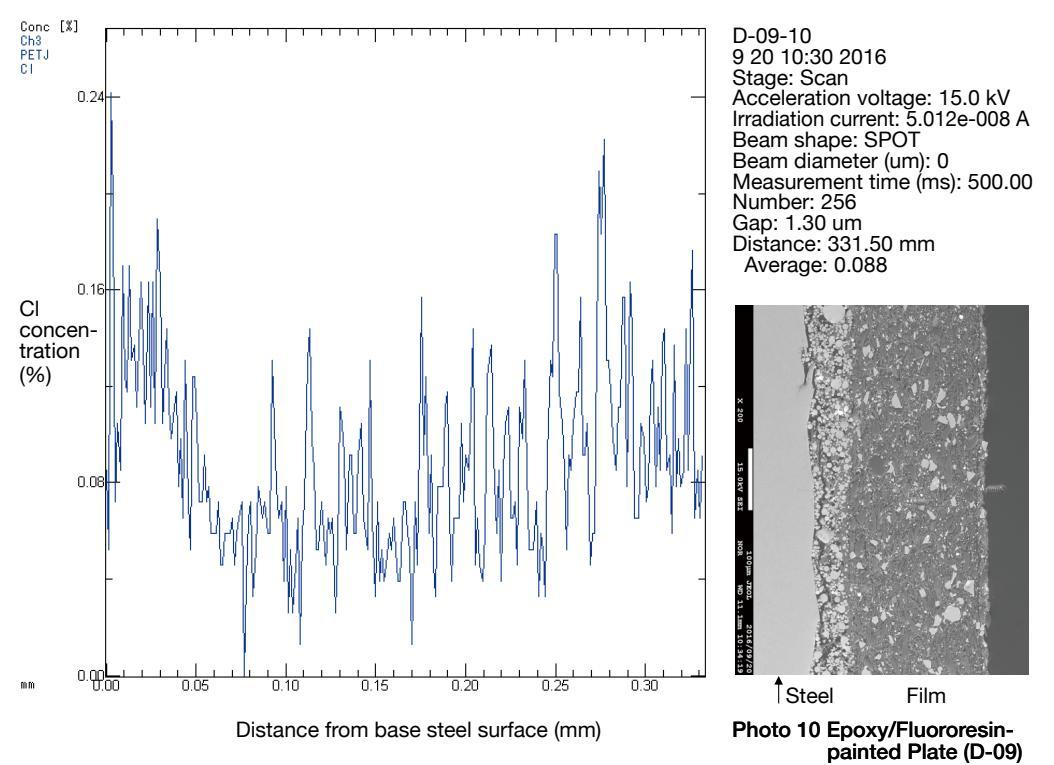
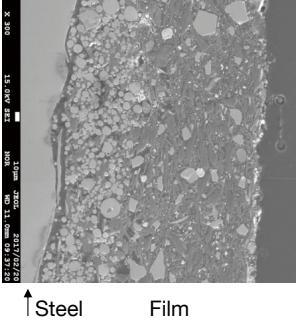
Photo 11 Epoxy Resin/Acrylic Silicon Resin-painted Plate (D-10)

As for the epoxy resin/acrylic silicon resin-painted plate (D-10), it was seen that chlorine did not penetrate into the painting film and chlorine did not concentrate at the painting film.

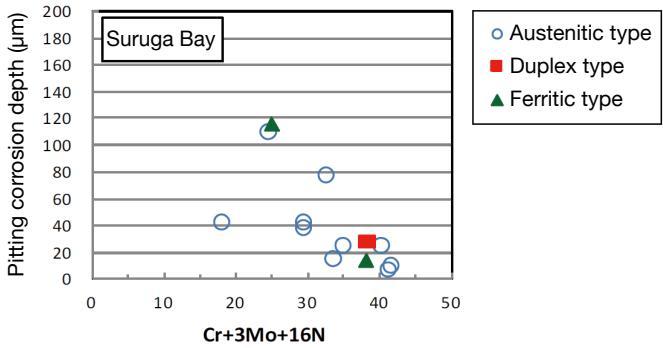
Fig. 8 Relationship between Maximum Crevice Corrosion Depth of Stainless Steel and Pitting Corrosion Index (PREN) (Insulation Washer-Specimen Gap)

Further, the maximum pitting corrosion depth at the general section and the maximum crevice corrosion depth at the insulation washer-specimen gap were organized using the PREN (Cr+3Mo+10N) used in the "*Research on Corrosion-protection Technologies for Steel Structures in Splash, Tidal and Submerged Zones*" of the Public Works Research Institute, and as a result, it was known that these depths can be organized even by the use of PREN (Cr+3Mo+10N) as with the use of PREN (Cr+3Mo+16N) as used in the survey (refer to Figs. 9 and 10).
