STEEL CONSTRUCTION

TODAY & TOMORROW

Special Feature: The 2011 Great East Japan Earthquake

- 1 How to Interact with and Prepare for Natural Disasters?
- 3 Coastal Facilities: Lessons Learned from the Quake and Tsunamis
- 6 Damage to River Levees and Measures for Restoration and Reconstruction
- 9 Liquefaction-induced Damage to Houses and Buried Lifelines
- 15 Treatment of Debris and Tsunami Deposits, and Their Effective Utilization for Restoration and Reconstruction

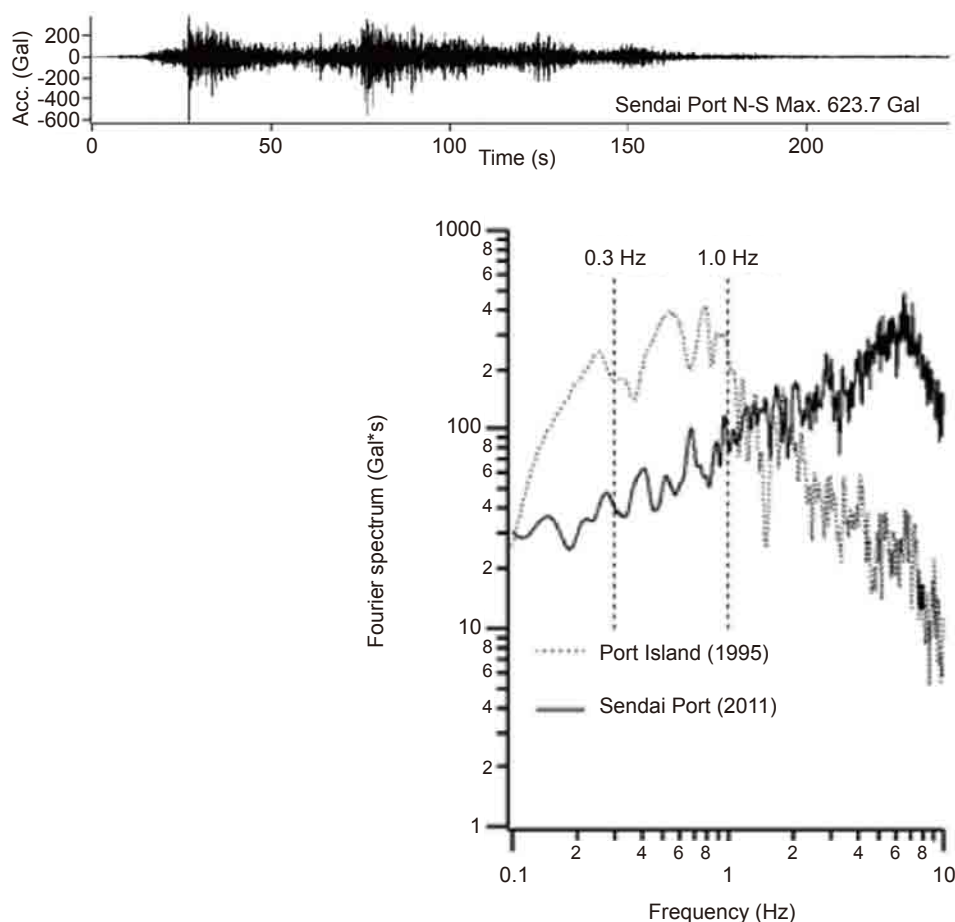
Fig. 1 Comparison of Acceleration Time History and Fourier Spectrum between the Port Island (1995 Hyogoken-Nambu Earthquake) and the Sendai Port (2011 Earthquake)

team as they investigated coastal structures along approximately 600 km of coastline, the follow-up experiments and analyses. A characteristic feature of the ground motion observed is the long duration and high frequency component, as shown in Fig. 1. For the reason, the degree of damage of coastal facilities by the ground motion was rather small. This broad coverage of investigation thus far made facilitated the interpretation of damage patterns across the entire region affected by the earthquake, by distinguishing coastal structure damages due to strong ground shaking and secondary effects (i.e., liquefaction, ground failures, settlement) caused by subsequent, significant tsunami inundation.

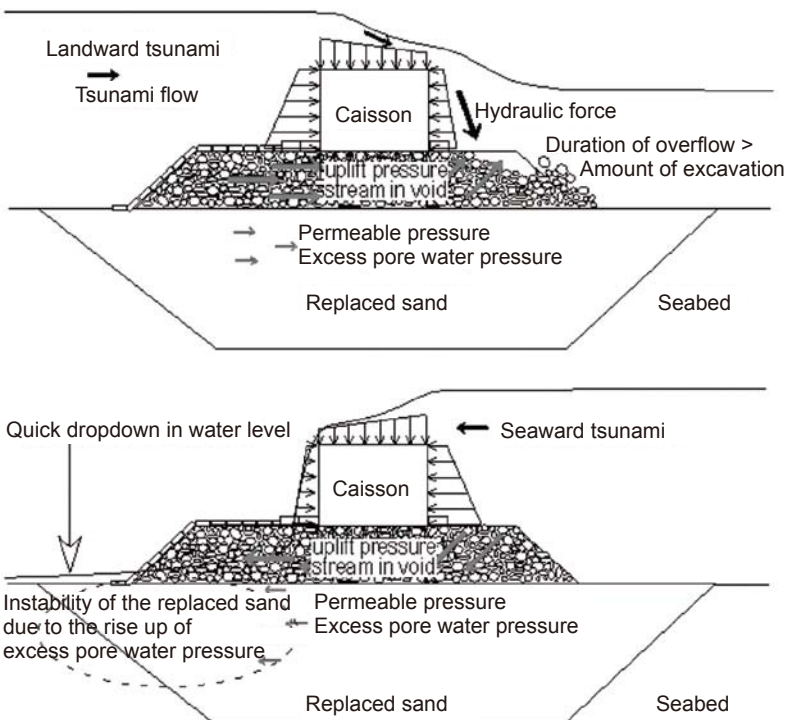
Fig. 2 Assumed Destruction Mechanism of Breakwater

- a) High response acceleration, large deformation, material degradation such as liquefaction, and growth of cracks that occur
- b) Tsunami wave force, hydraulic force of flow such as drag force, buoyancy, impact of floating objects during tsunami attack. Especially, during a seaward tsunami, destabilization of the pore water pressure in the ground may occur, like the quick drawdown phenomenon, as shown in Fig. 2 (lower figure)

At present, the cause of damage and the tsunami-affected actual damage mechanism have not yet been clarified. We are promoting experimental and numerical research in order to clarify the mechanism of damage caused by the combined action of the earthquake and tsunami.

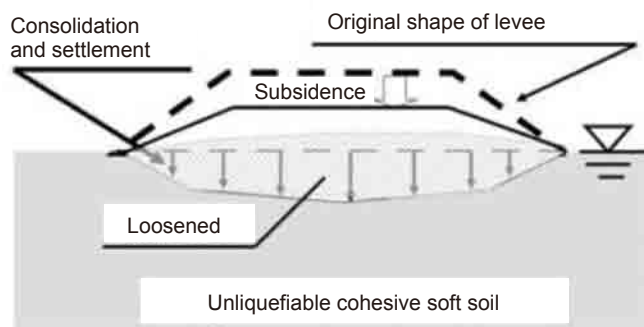
Fig. 2 Schematic Illustration of Mechanism of Liquefaction inside a Levee

levees consists of subsidence at the crest and lateral spreading, which is a typical nature of liquefaction-induced deformation of an embankment, those damage shown in Photo 2 is inferred to have been caused by liquefaction inside levee bodies. The mechanism of this new idea is considered to be as what follows as studied by Sasaki et al. (1994)¹⁾ and Kaneko et al. (1996)²⁾ on previous cases of Tokachi and Kushiro Rivers in 1993 (Fig. 2):

- 1) A river levee sinks into soft clayey subsoil because of consolidation,
- 2) The sunken part has poor drainage of infiltrated rain water and seeping ground water because the elevation is lower than the ground surface, and the surrounding soil is less pervious clay, and
- 3) The procedure of subsidence and consequent lateral expansion is possibly accompanied by loosening of soil and reduced liquefaction resistance.

The problems related with the internal liquefaction are such as difficulties in detecting a liquefaction-prone levee and drainage of water from this type of a levee.

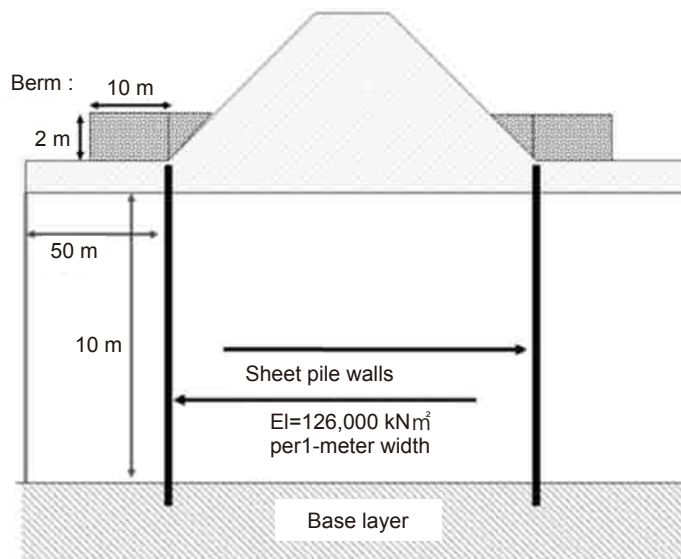
Fig. 4 Sheet-pile Walls and Counter-weight Berm as Mitigation Measures

At Sakae of Ibaraki, the Tone River levee had been reinforced by underground sheet pile walls (for reducing seepage of water) accompanied by a wide berm on the river side. During the earthquake, no distortion occurred on the river side (Photo 3). In contrast, the land side of the levee distorted due to liquefaction in the foundation soil in which the ground water level is within 50 cm from the surface (the author's observation in April, 2012). The damaged section was restored by installing 8-m sheet piles along the slope toe (Photo 4). The holes in the sheet pile allow seepage of ground water so that the water level in the levee would be lowered during high water level in the river.

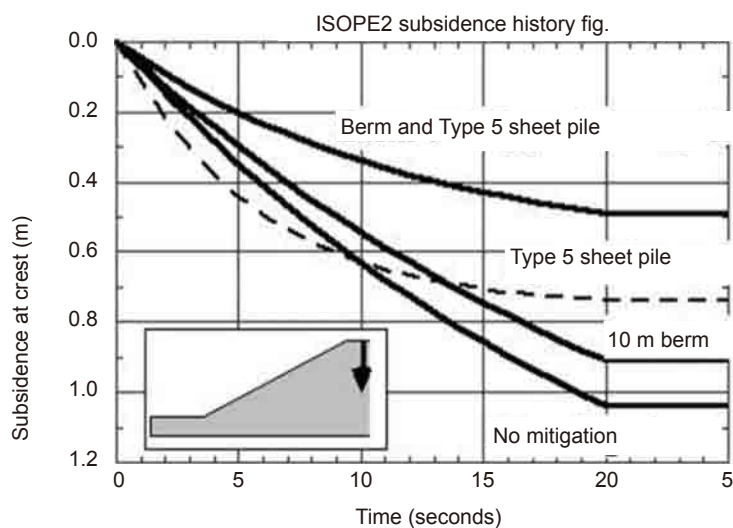
Fig. 5 Mitigation of Subsidence of Levee Undergoing Liquefaction in Foundation

The author proposed a viscous modeling of liquefied sand for performance (deformation) assessment of structures subject to strong shaking (Towhata et al., 1999 and 2010)^{4,5} and developed a numerical program. Fig. 3 is a levee model for an example analysis, of which the performance (settlement at crest) is mitigated by embedded sheet pile walls, counter-weight berms, or both (Fig. 4). Results of a flow analysis as shown in Fig. 5 demonstrate that a combination of a sheet pile wall and a counter-weight berm can reduce the crest subsidence to less than 50% after strong shaking and soil flow of 20 seconds.

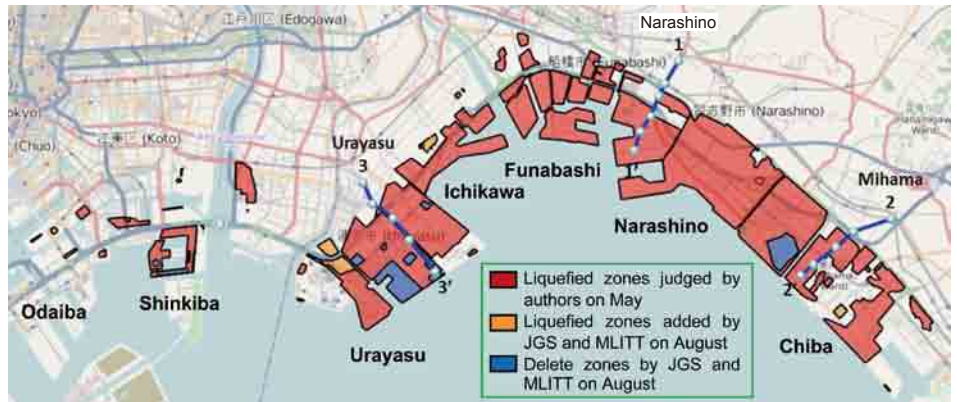
Fig. 2 Liquefied Area from Odaiba in Tokyo to Chiba City

houses, river dikes, roads, lifelines and ports and harbors were serious, Kanto Regional Development Bureau of the Ministry of Land, Infrastructure, Transport and Tourism intended to make joint research with JGS to identify liquefied sites. Fig. 2 is the map of liquefied zones thus estimated, which is slightly modified from the tentative map.

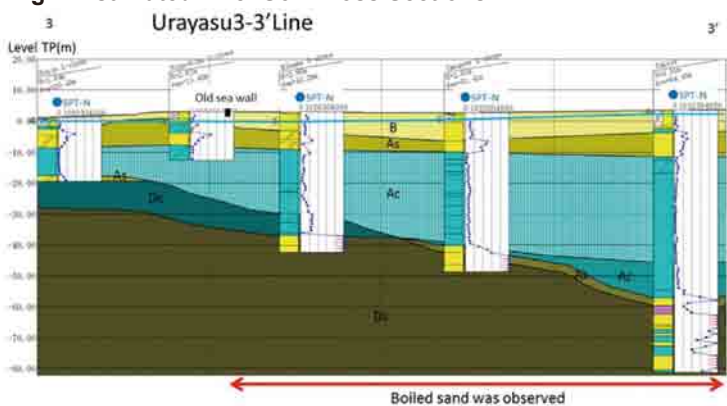
Fig. 4 Estimated Brief Soil Cross Sections

As three sets of data base had been published by JGS, Chiba Prefecture and Tokyo Metropolitan Government in the liquefied area, the authors estimated brief soil cross sections along 11 lines which are perpendicular to the shore lines based on these data. Fig. 4 illustrates the estimated soil cross sections along a line in Urayasu 3-3' together with the zones where sand boils were observed. The zones where sand boils were observed are exactly coincided with the area of reclaimed land

which is the sea side from old sea wall. In the reclaimed zone, a filled layer with mainly hill sand (B) and a filled layer by dredged sandy soil (F) with low SPT N -values of 2 to 8 are deposited with a thickness of 6 to 9 m. An alluvial sand layer (A_s) with SPT N -values of 10 to 20 underlay with a thickness of 4 to 8 m. A very soft alluvial clay layer (A_c) is deposited under the A_s layer with a thickness of 10 to 40 m, by increasing the thickness towards sea. Diluvial dense sandy layer (D_s) with SPT N -value of more than 50 underlay. Water table is shallow as GL -0.5 m to -3 m, by decreasing the depth towards sea. On the contrary, in the zone where sand boil was not observed, A_s layer deposited from ground surface. Therefore it can be estimated that the A_s layer basically did not liquefy by the 2011 Great East Japan Earthquake though some loose part might liquefy in the reclaimed land, and that some part of the dredged sandy soil under water table might liquefy. Composition of soil layers is similar in other 10 soil cross sections, though

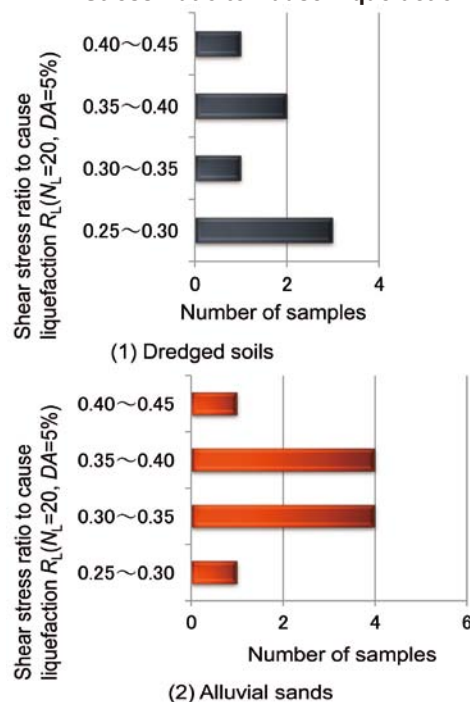
Fig. 6 Frequency Distributions of Shear Stress Ratio to Cause Liquefaction

cycles tested by cyclic triaxial tests, R_L ($N_L=20$, $DA=5\%$) for the F and the A_s layers, are shown in Fig. 6. Dominant R_L values for the F layer and the A_s layer are 0.25 to 0.30 and 0.30 to 0.40 respectively though the data are very scattered in the F layer. Therefore it can be said the soils in the F layer are more liquefiable than those in the A_s layer.

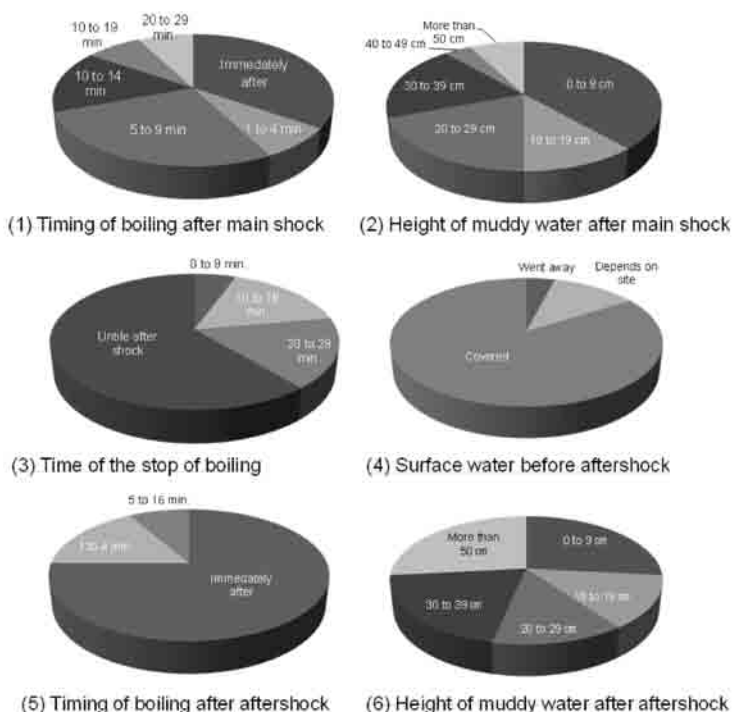
Fig. 7 Questionnaires to Inhabitants in Irifune

30 inhabitants in Irifune district which is also located in Urayasu City to ask the timing of boiling and height of boiled muddy water. Answers are summarized in Fig. 7. About 1/3 persons observed the boiling of muddy water immediately after the main shock, however another 1/3 persons recognized the spout of muddy water 5 to 9 minutes after the main shock. Other persons found the muddy water at different timing. Height of the muddy water was not high as mainly less than 9 cm after the main shock. About 2/3 persons mentioned that the boiling of muddy water continued up to the aftershock, and about 3/4 persons watched covered water until aftershock. On the contrary, about 3/4 persons observed spew out of muddy water just after the aftershock and the

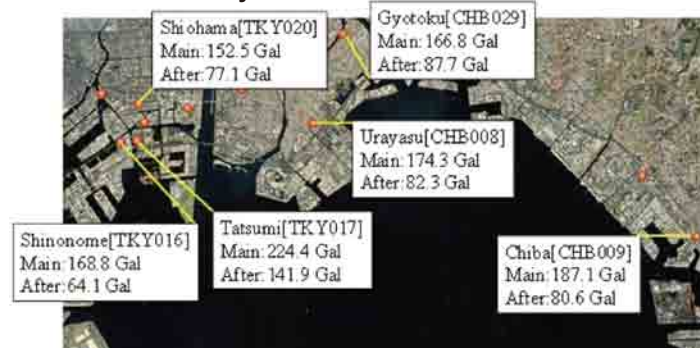
Fig. 8 Comparison of Accelerations during Main and Aftershocks by K-NET

Fig. 8 shows ground surface accelerations during the main shock and the aftershock. Surface accelerations were not high as around 160 cm/s^2 to 230 cm/s^2 though severe liquefaction occurred. The accelerograph, recorded at K-NET Inage in Chiba where actually boiled sand was observed, is very important because liquefied time can be judged from the recorded waves. Fig. 9 shows the accelerograph at Inage together with that at K-NET Urayasu which was recorded on the ground where liquefaction did not occur. Both records started almost same

One more impact to the ground must be the shaking during the aftershock. Peak accelerations during the aftershock were almost a half of those during the main shock in Tokyo Bay area as shown in Fig. 8. Even though, as mentioned above, boiling

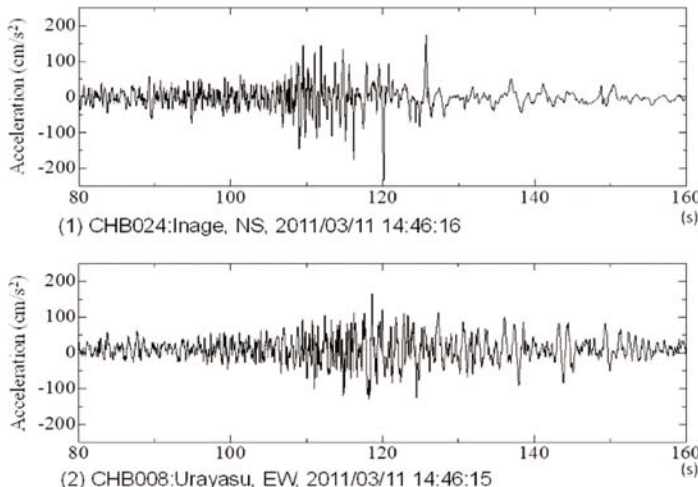
Fig. 9 Comparison of Accelerographs Recorded at K-NET Inage and Urayasu

time; 14:46:16 at Inage and 14:46:15 at Urayasu. In Urayasu's wave, frequency did not change drastically after the peak acceleration which induced at about 118 sec. (14:48:13). On the contrary frequency changed to low value after two peaks at 120 sec. (14:48:16) and 126 sec. (14:48:22). Therefore it can be judged liquefaction occurred at around 14:48:16 to 14:48:22 at K-NET Inage. This means many cycles of shear stress, say around 20 cycles from 110 sec., might cause liquefaction at K-NET Inage site. And it must be noted shaking still continued for long time after the occurrence of liquefaction. By referring to the accelerograph at K-NET Urayasu, shake of the ground at Inage continued for about 3 minutes after liquefied.

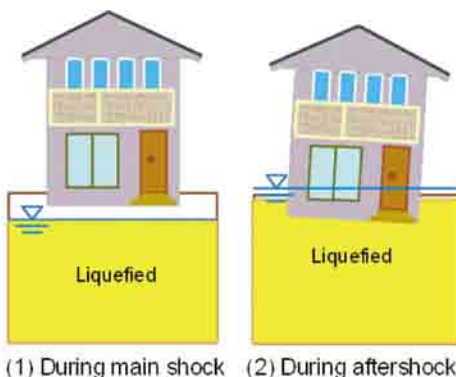
Fig. 14 Possible Effect of Aftershock on the Settlement of House

As mentioned above, occurrence of liquefaction must be affected by the aftershock. Not only the occurrence of liquefaction but also the settlement and inclination must be affected by the aftershock. Ground water table increased after the main shock and boiled muddy water covered the ground surface until the aftershock at many sites. Then, settlement of houses is excitable during the aftershock though shaking amplitude was less than that during the main shock as schematically shown in Fig 14.

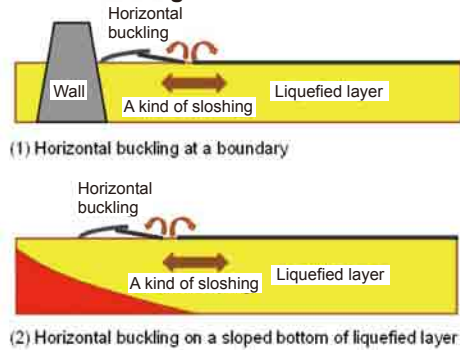
Fig. 15 Two Possible Mechanism of Heaving

boundaries due to a kind of sloshing of liquefied ground as schematically shown in Fig. 15 (1), because shaking continued for long time after the occurrence of liquefaction. Fig. 16 shows heaved footways or alleys in Urayasu City together with contour lines of the thickness of the F layer under the ground water table. It may be said that the heaving occurred at the sites where the bottoms of the F layer, in other word liquefied layer, are sloped. This implies that a kind of horizontal buckling of surface layer might occur due to the concentration of horizontal compressive stress as schematically shown in Fig. 15 (2). However, more studies are necessary on the mechanism of the buckling.

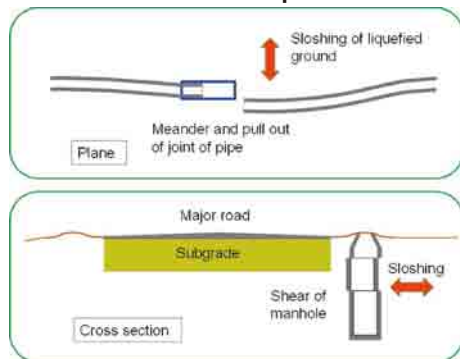
Fig. 17 Unique Damage to Sewage Manholes and Pipes

In sewage facilities, pipes meandered or were broken, joints were pulled out and pipes were filled with muddy water. Many manholes were sheared in horizontal direction and filled with muddy water whereas few manholes were uplifted. Though the mechanism of these unique damages is still being studied, one author's idea is illustrated in Fig. 17. As mentioned above, a kind of sloshing of liquefied ground might occur due to long duration of shaking and caused thrust of roads. By the same movement of the ground, pipes might meander violently in horizontal direction, resulting in pull out or break of joints, and eventually liquefied muddy water invaded into the pipes. Manholes might be sheared due to horizontal force and pressurized liquefied muddy water came into the manholes. Fortunately or unfortunately invaded muddy water into the sewage pipes and manholes might prevent uplift.

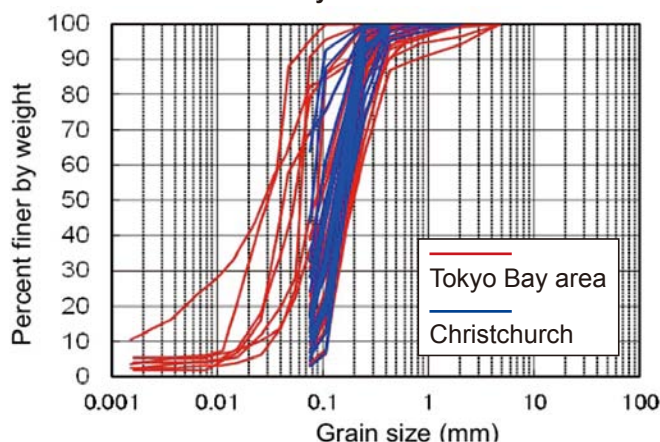
Fig. 18 Comparison of Grain Size Distribution Curves of Boiled Sands in Tokyo and Christchurch

Much eruption of sands and large ground subsidence occurred in the liquefied area. The maximum thickness of the erupted sand and the maximum ground subsidence observed by the authors were about 30 cm and 50 cm respectively. This is the first experience for the authors to see such thick deposited boiled sand in Japan. However, one of the authors had seen similar much eruption and large subsidence in Christchurch during the main shock on September 2010 and aftershock on February 2011. Fig. 18 compares grain size distribution curves of erupted soils in Christchurch during the main shock with those in Tokyo Bay during this

earthquake. Fines contents for Christchurch and Tokyo Bay are similar. Then it is estimated that in the very fine sands, ejection of water continues for long time because of low permeability of liquefied soils in both area. Moreover fine soil particles are easy to uplift above the ground surface by the ejecting water. And the removal of the deposited soils by inhabitants accelerated the settlement of the ground surface.

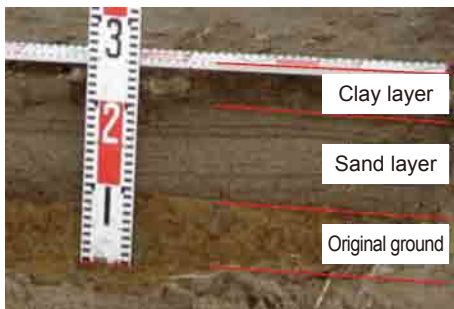
Photo 1 Tsunami deposits (courtesy: T. Yasutaka)
